## The restoration of Class NG10 number 61, 2017 progress.

### Boiler report from Keith Stevens, 5<sup>th</sup> May

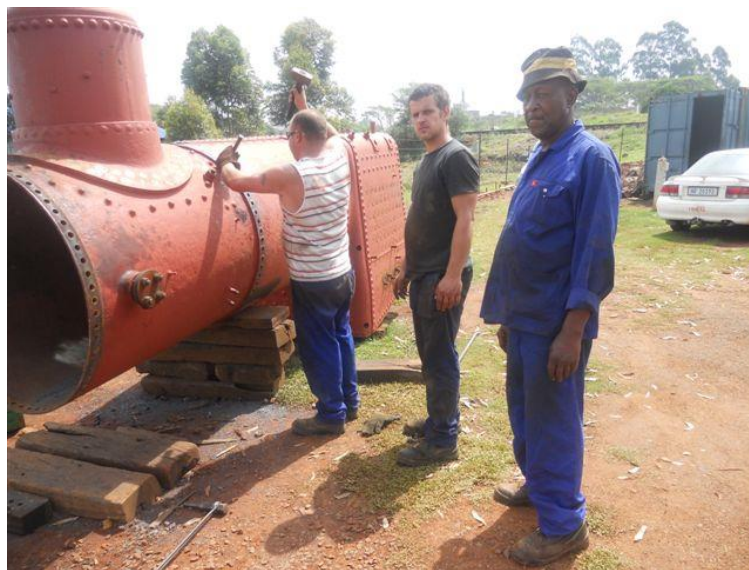
*Removing rivets*

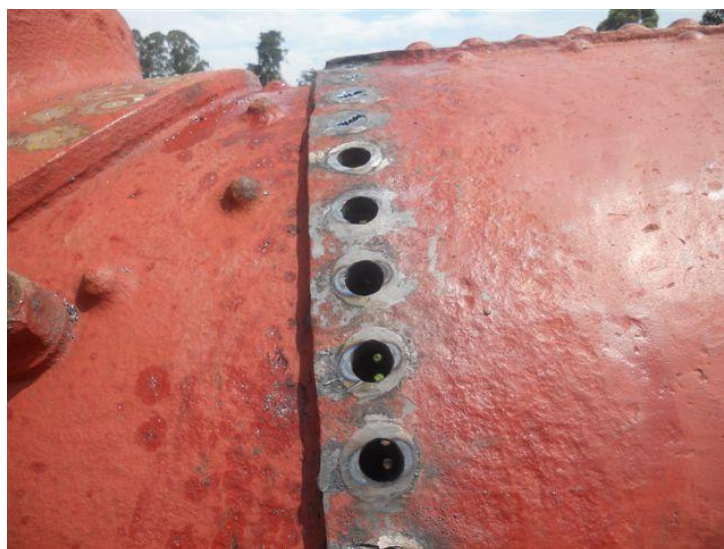
*Rivets removed*

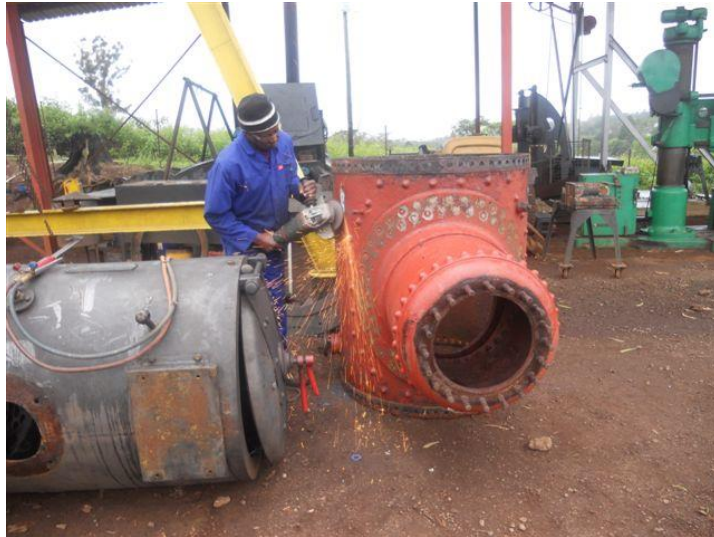
*Stripping the dome section*

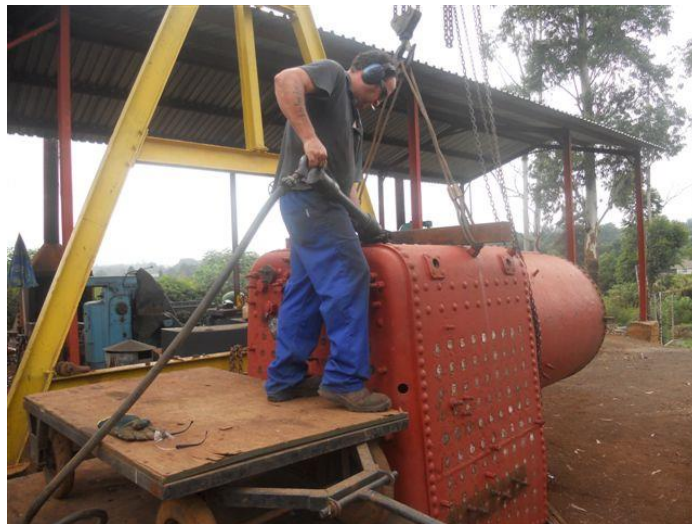
*Cutting the stay heads off*

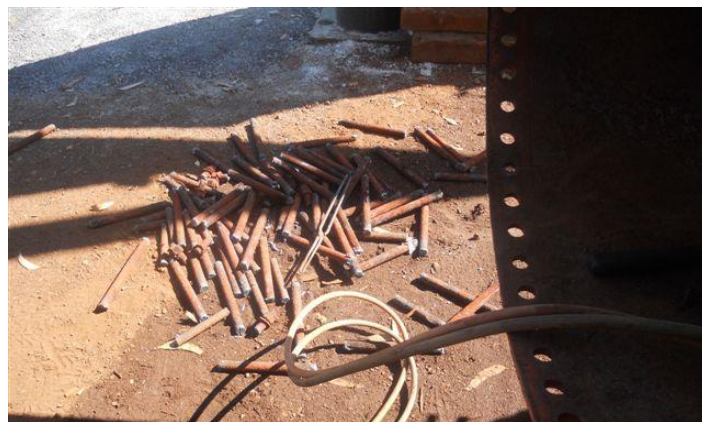
*The crown stays after being cut off*

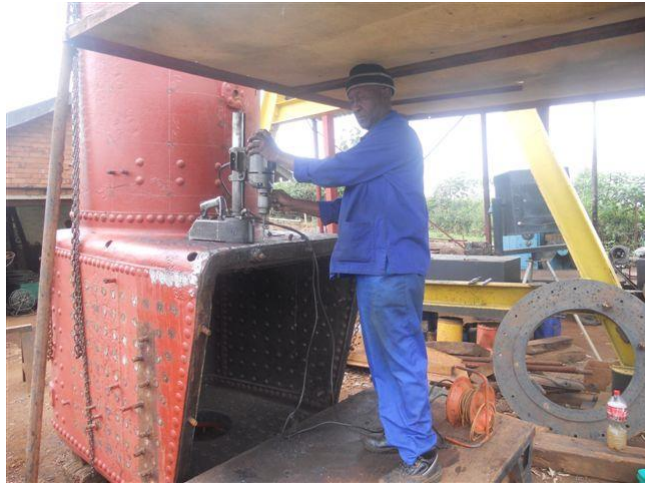
*The throat plate stays being drilled out*

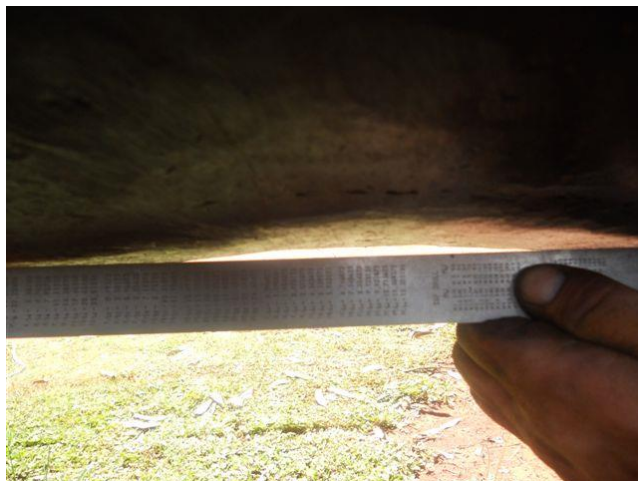
The boiler barrel also has a large bulge that must be attended to and our pictures from Keith show the work to repair the bulge.

*The extent of the bulge in the NG10 boiler barrel*

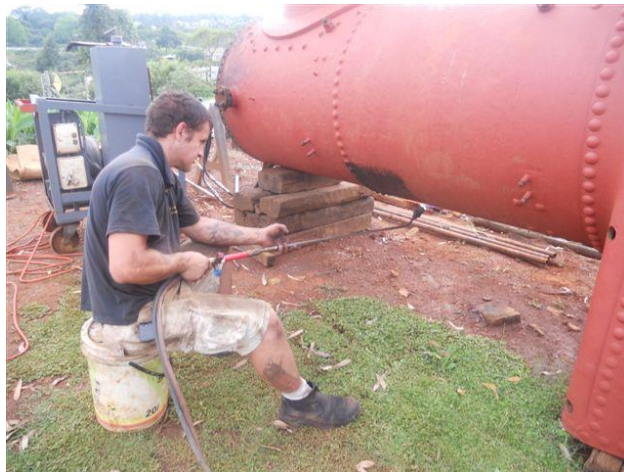
*Heating the area prior to the pressing out of the bulge*

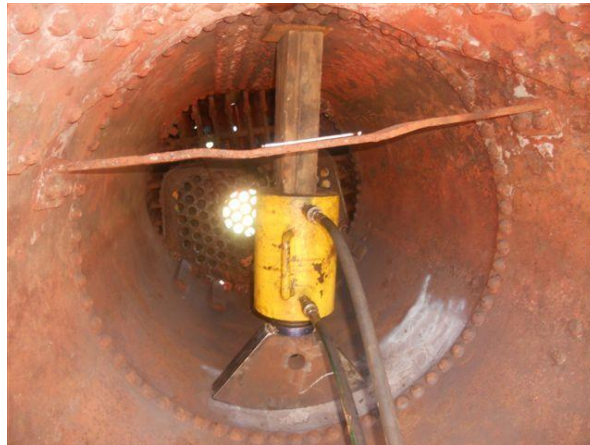
*Pressing out the bulge in the boiler barrel*

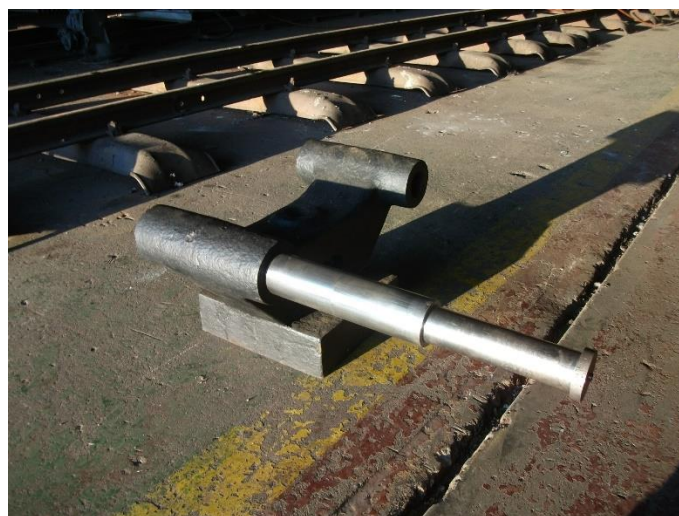
*The refurbished front bogie center.*

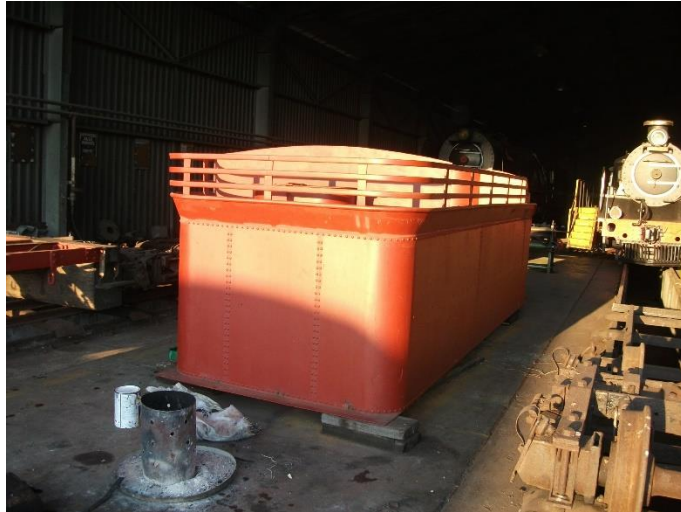
*The new tender tank.*

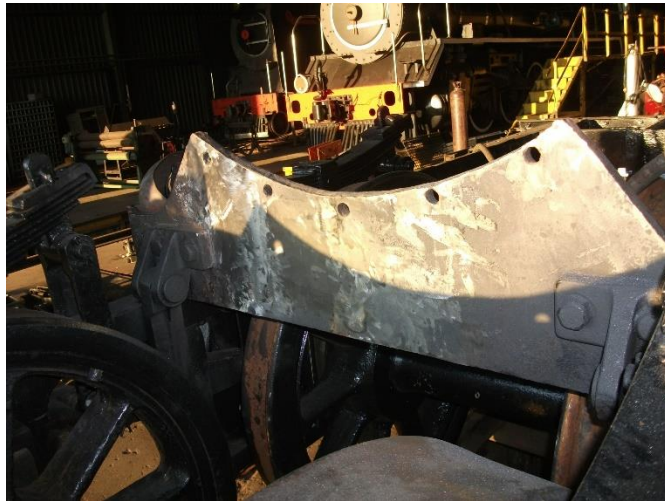
*The boiler belly plate.*

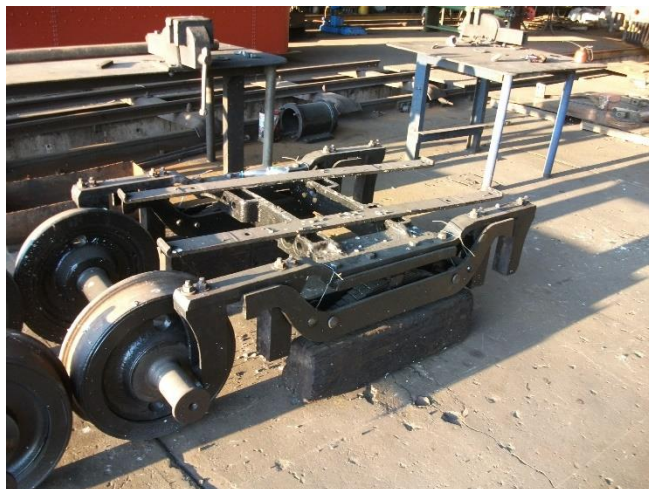
*The front bogie.*

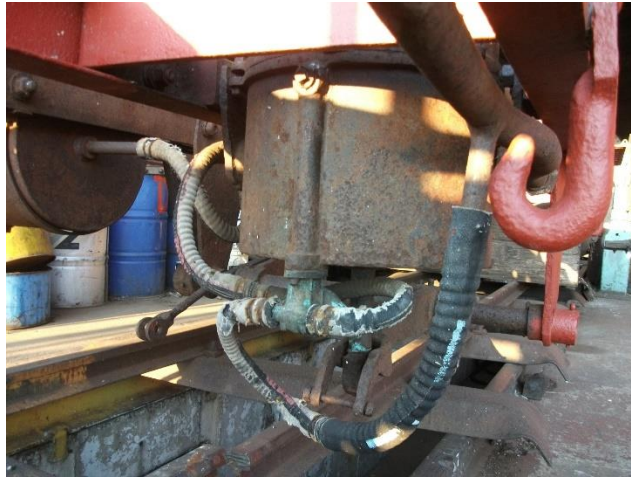
*The tender vacuum cylinder and brake gear.*

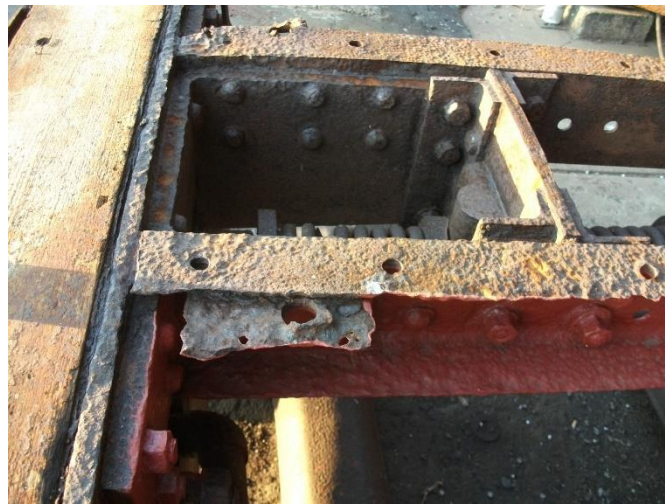
*The tender draw gear.*

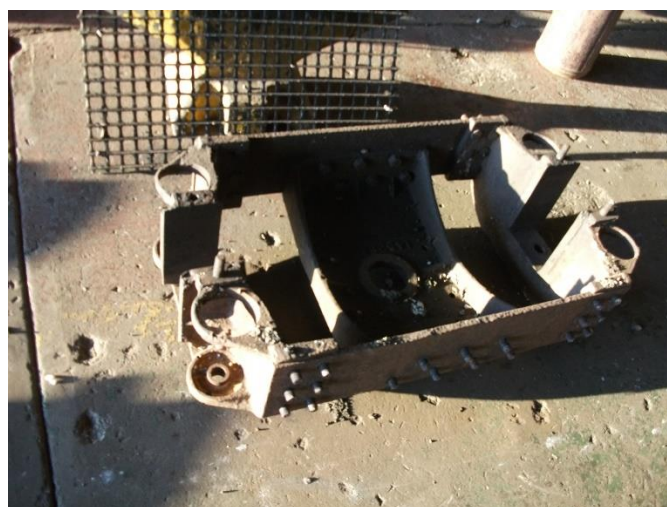
*The rear bissel frame.*

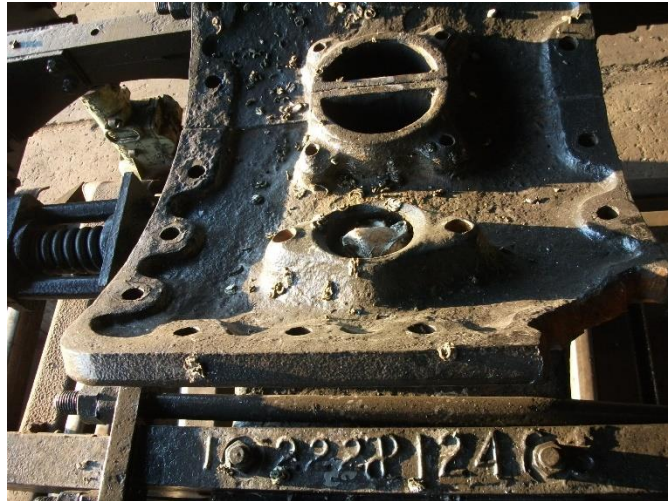
*The NG10 boiler saddle casting.*

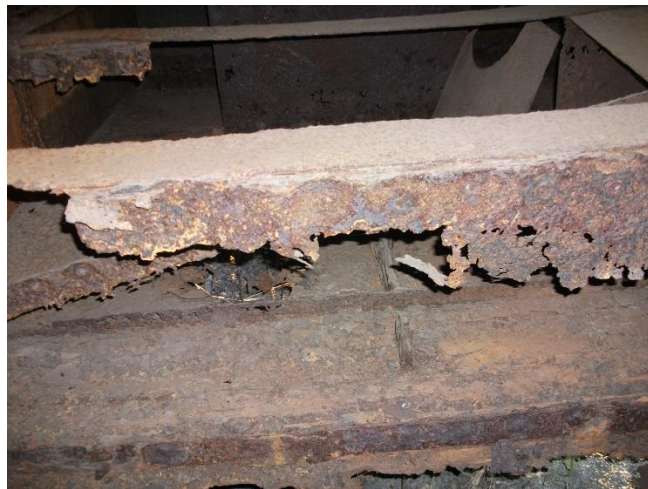
*The wasted interior of the old tender tank.*

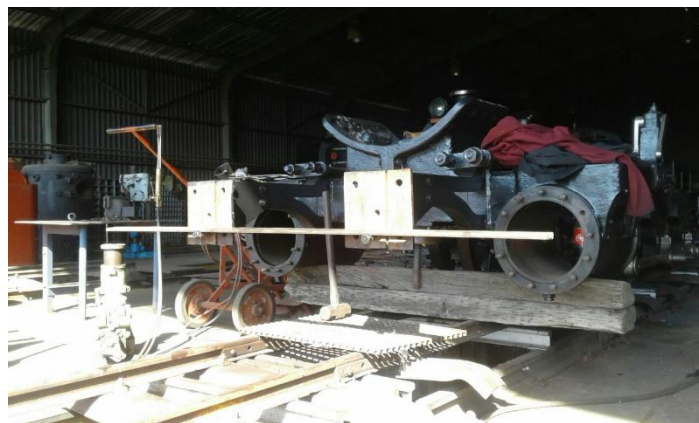
*Setting up the alignment of the buffer beam.*

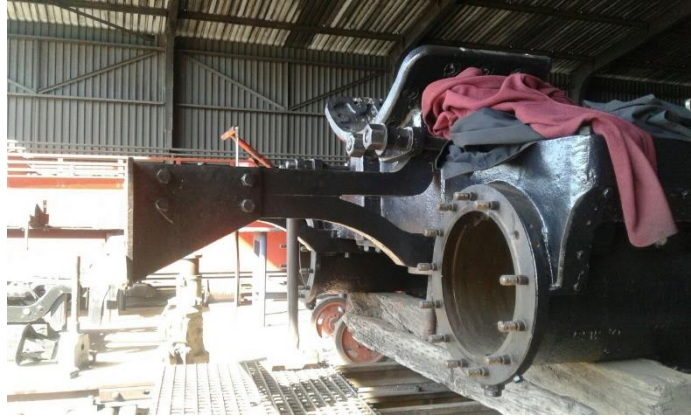
*Another view of the buffer beam.*

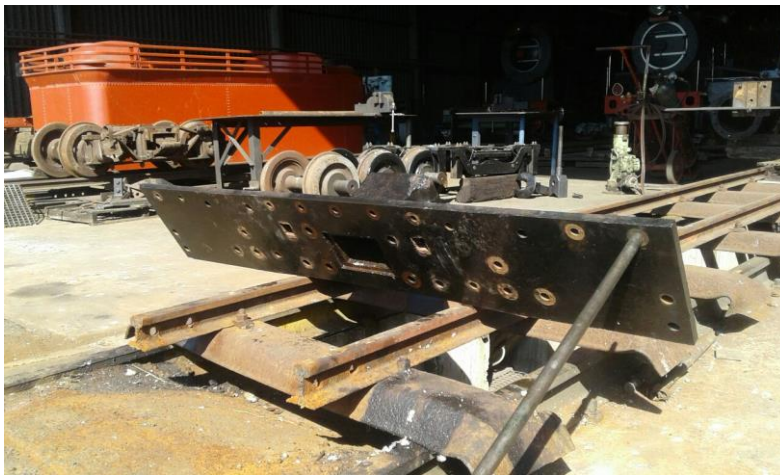
*The buffer beam after being re-aligned.*

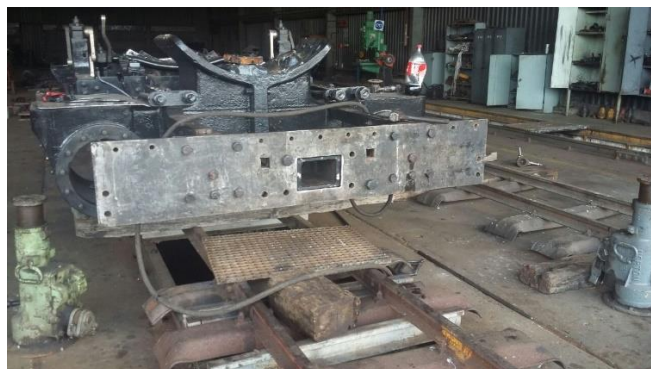
*The repaired buffer beam*

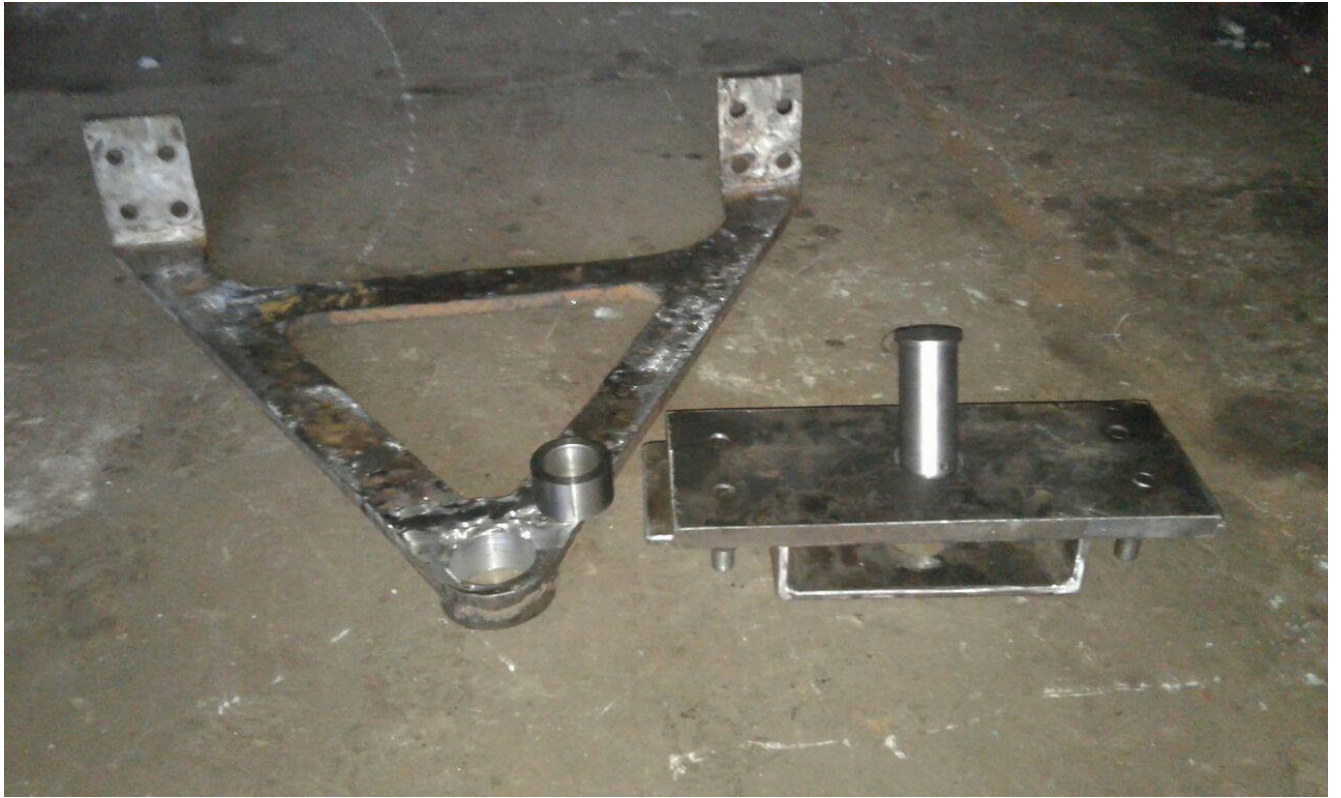
*The new bissel frame and stretcher*

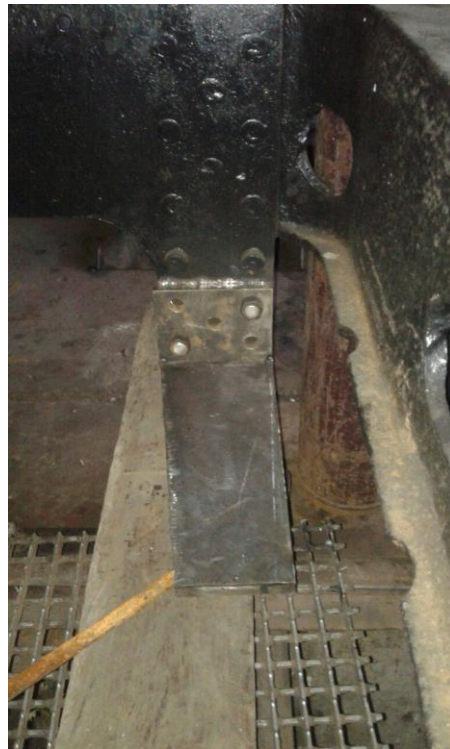
*The new frame support*

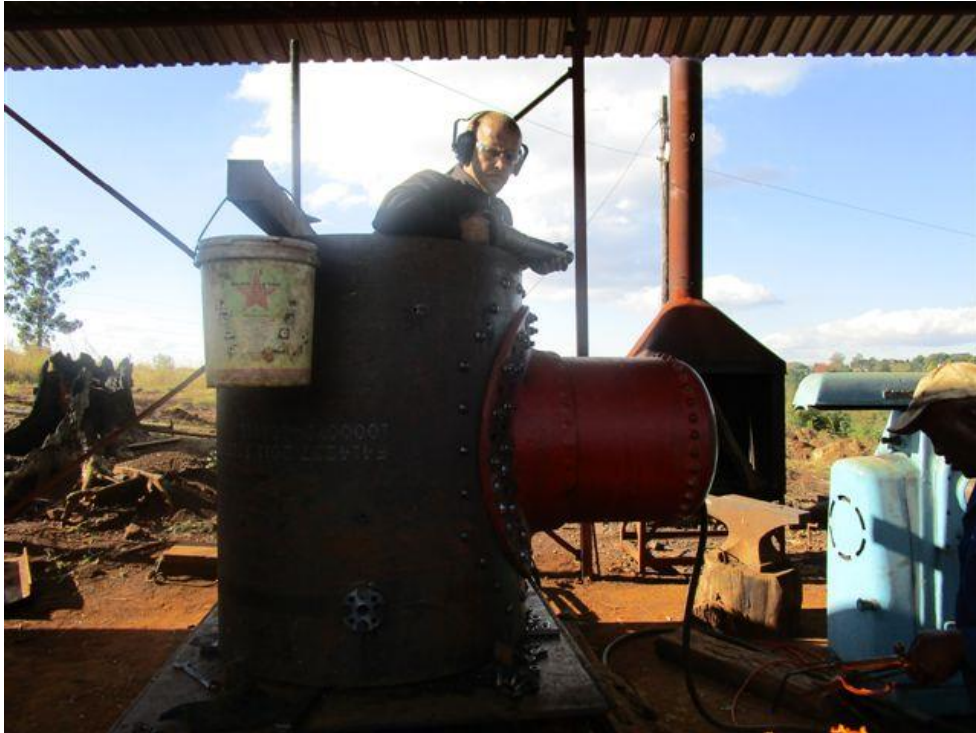
*Riveting the dome to the boiler barrel*

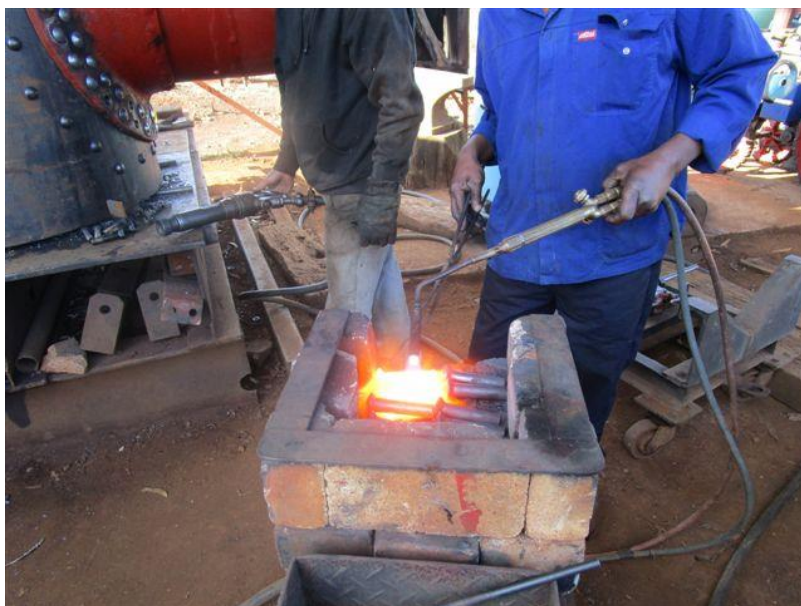
*Heating up rivets*

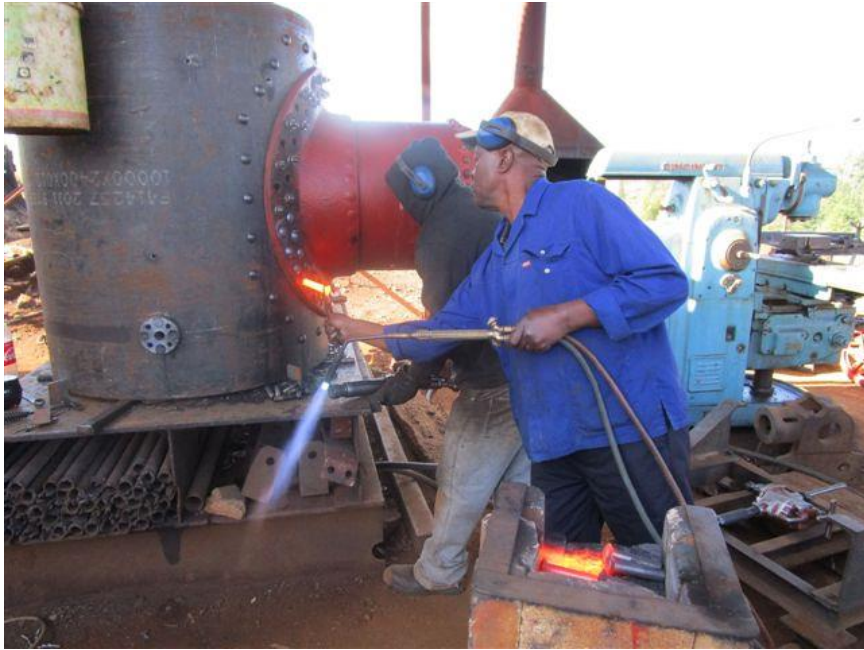
*Riveting the dome*

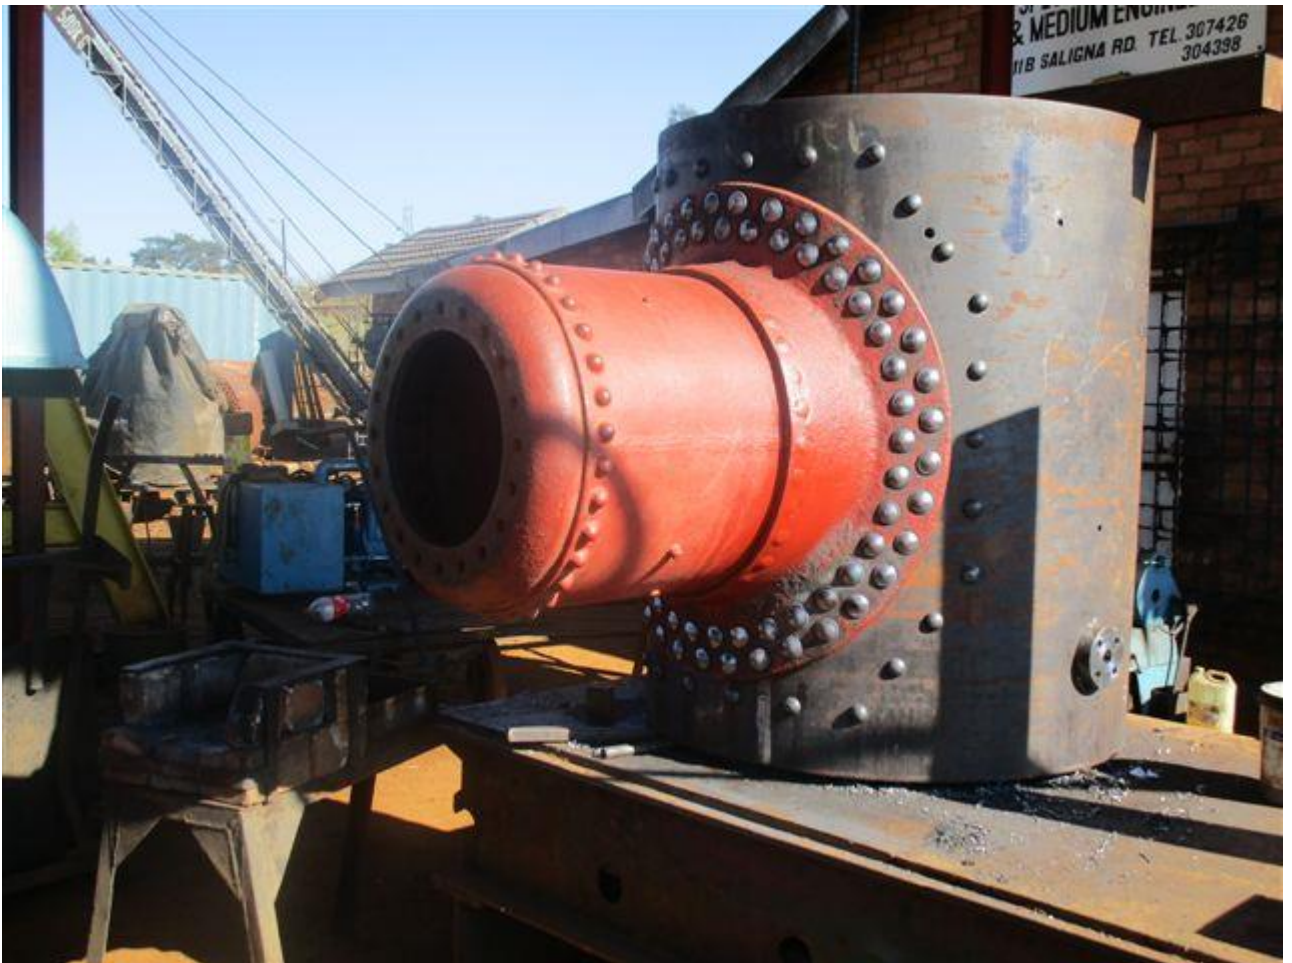
*Job complete*

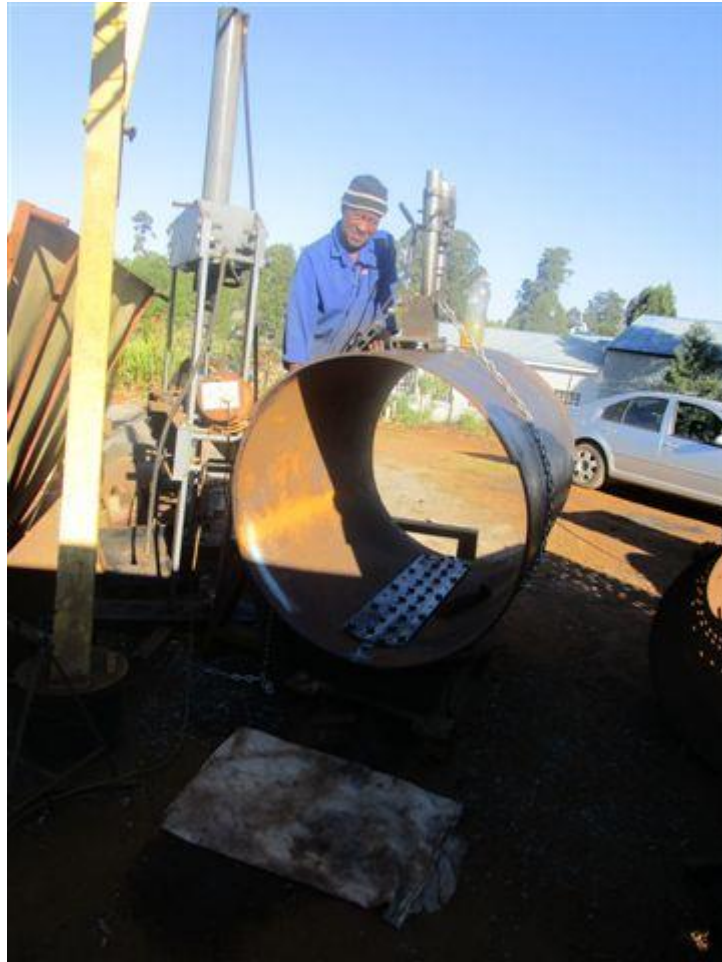
*Fitting butt strap on front boiler barrel section*

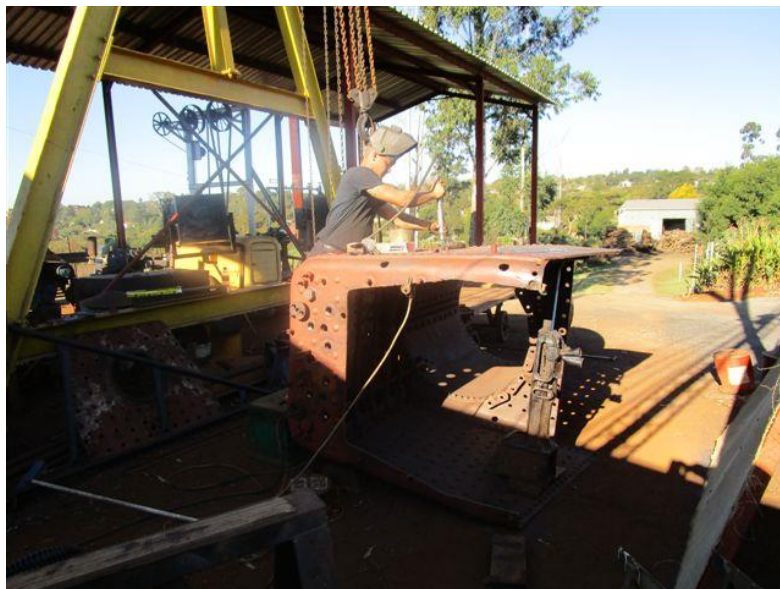
*Scaling back end of boiler*

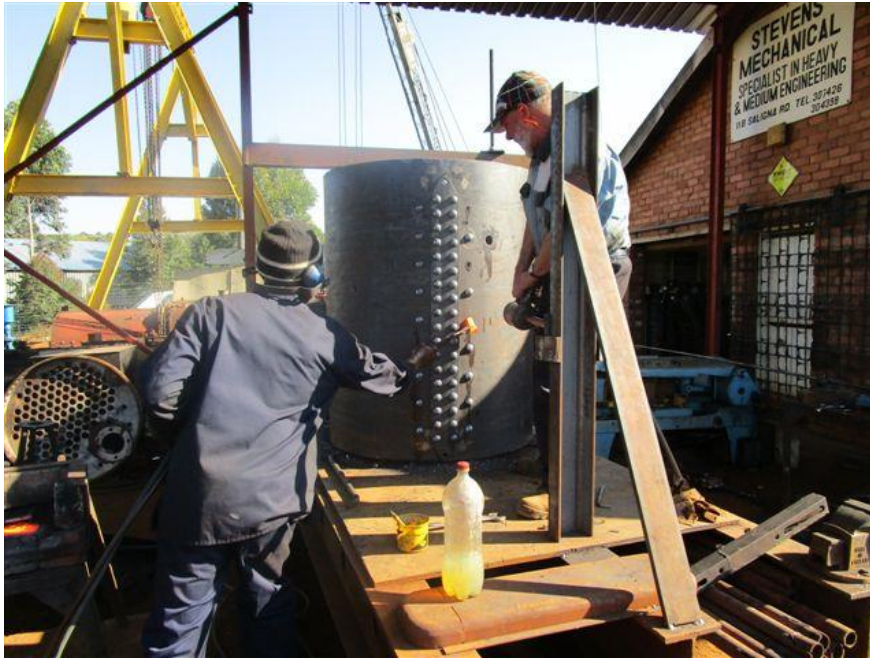
*Riveting up butt strap*

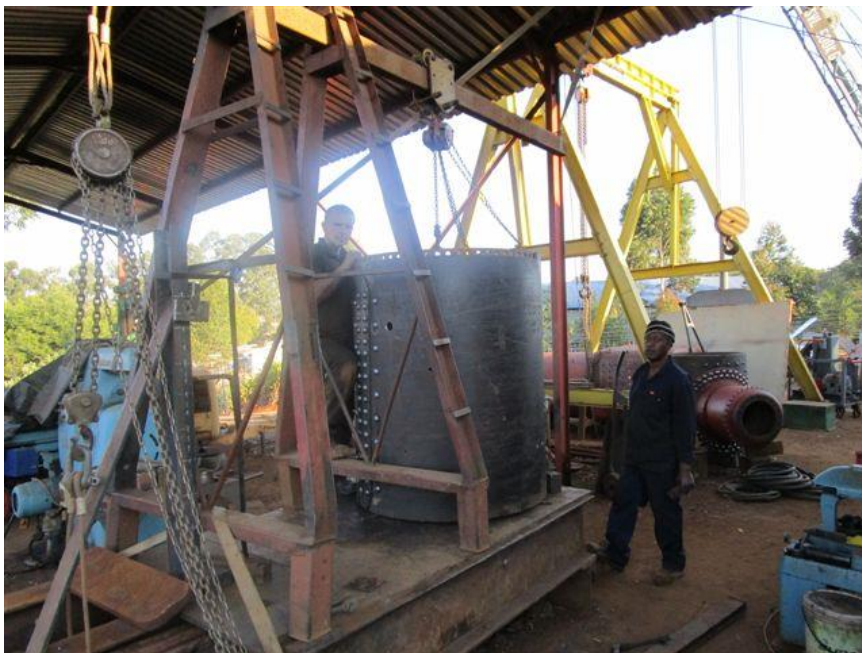
*Putting the tube plate in position*

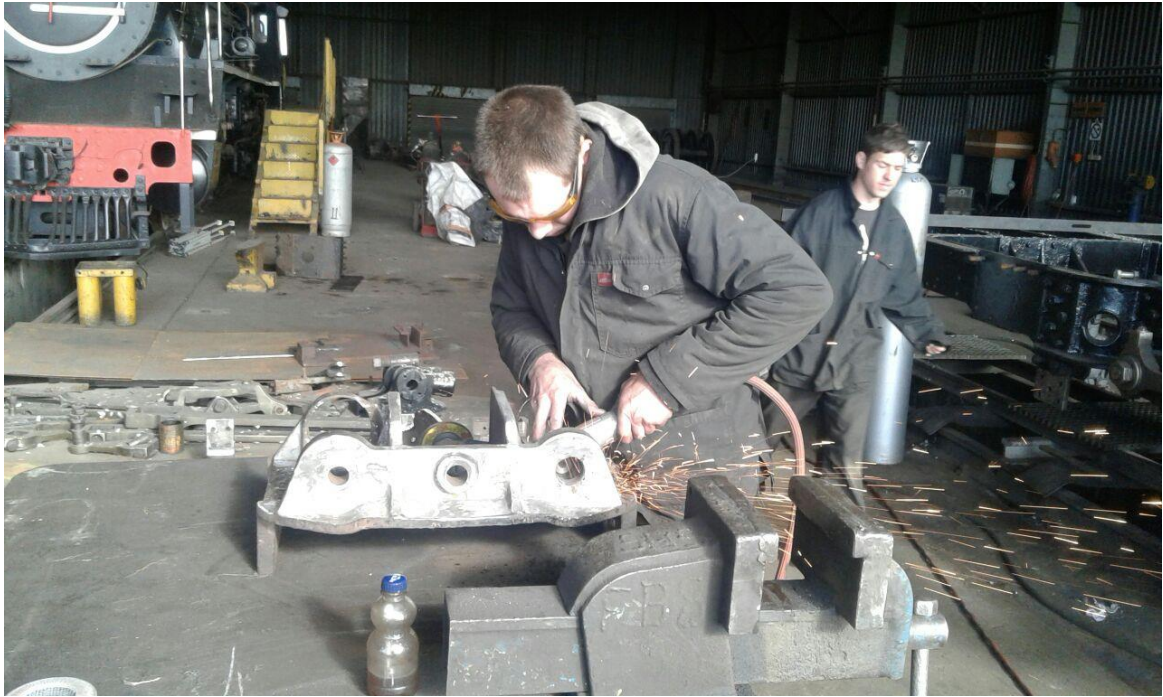
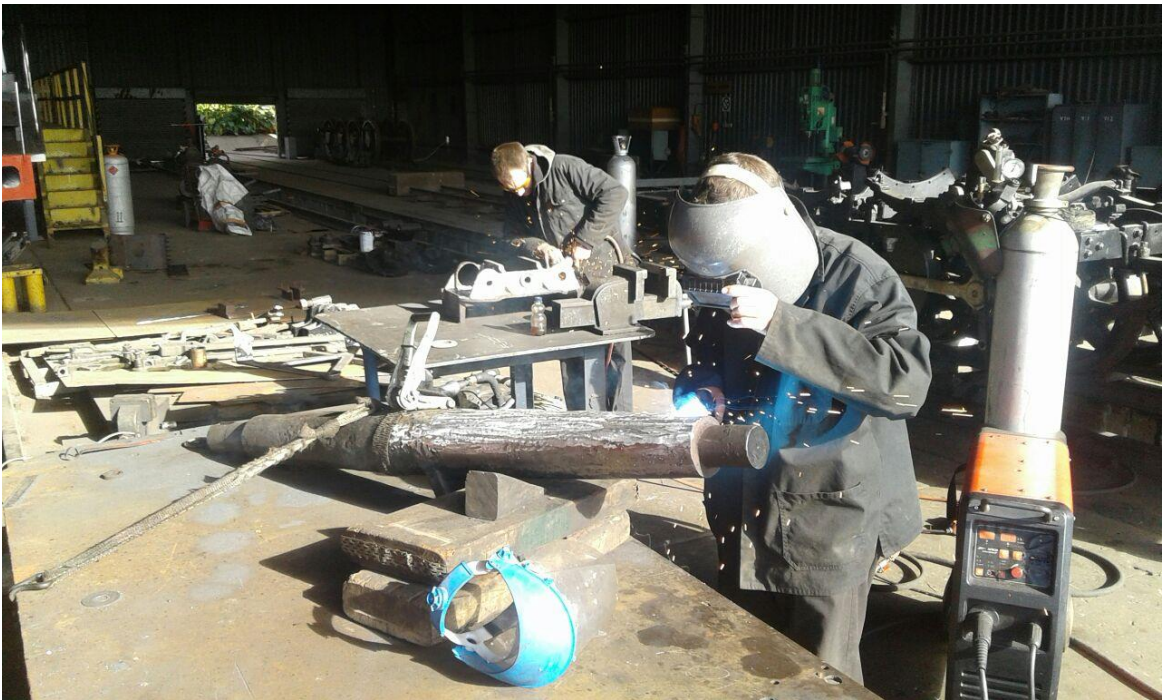
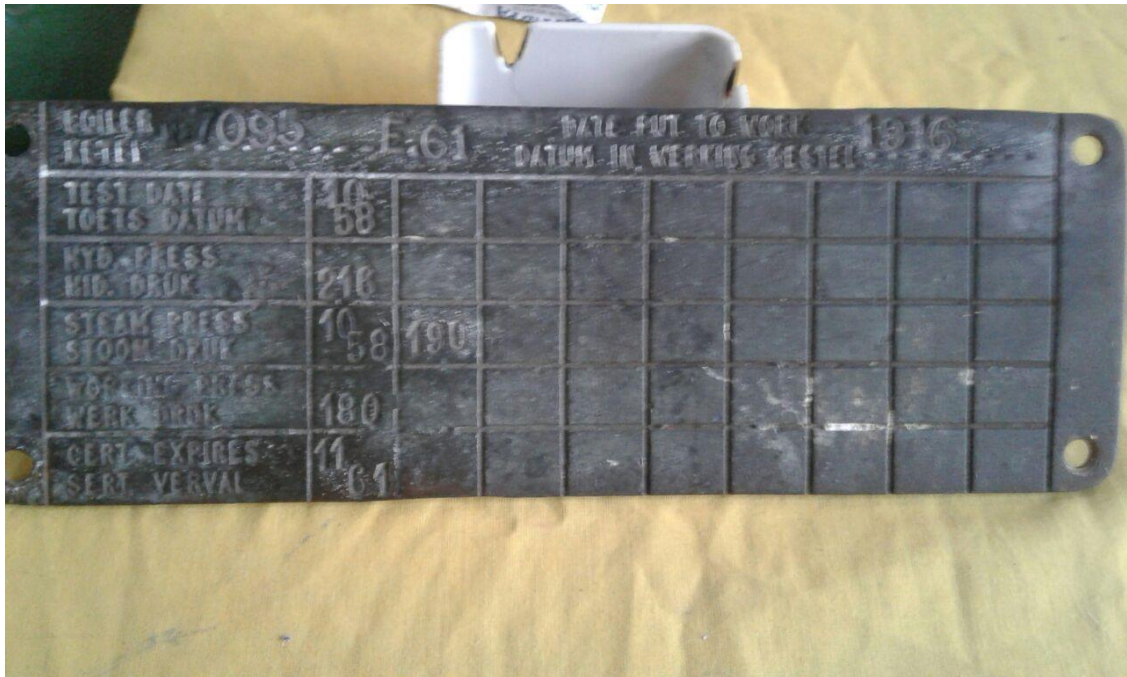
The new bissel castings and brake shaft are being prepared for some major machining work and welding over the next few weeks. Our pictures show the bissel being prepared by Isak vd Berg and a volunteer at work on the brake shaft. Lukas Nel has also retrieved the original boiler plate from number 61 showing its boiler is from 1916 and the last steam test was in October 1958. Renewal was due in November 61 but this was not done. This coincides with our information that the loco was withdrawn in 1961 for preservation but not in working order.

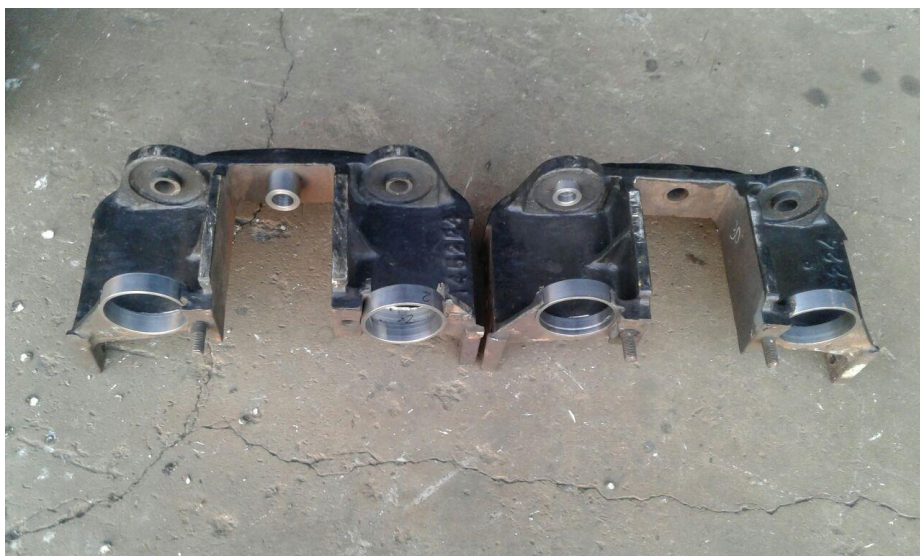
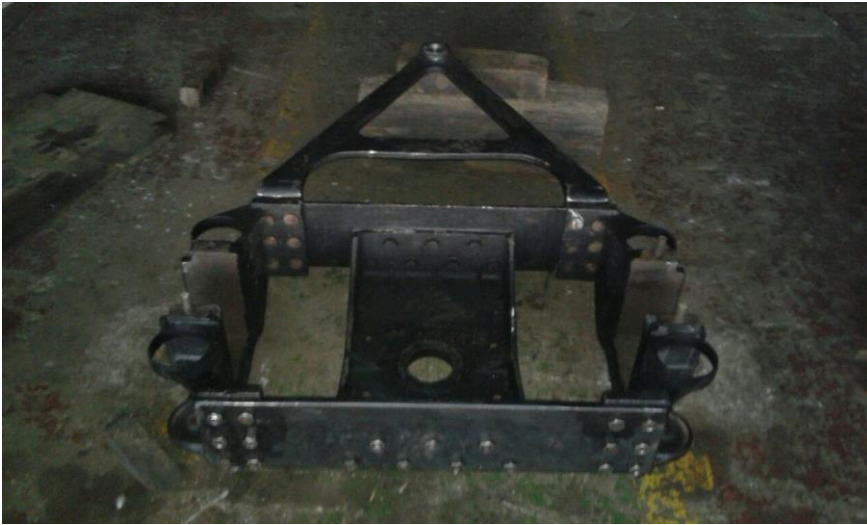
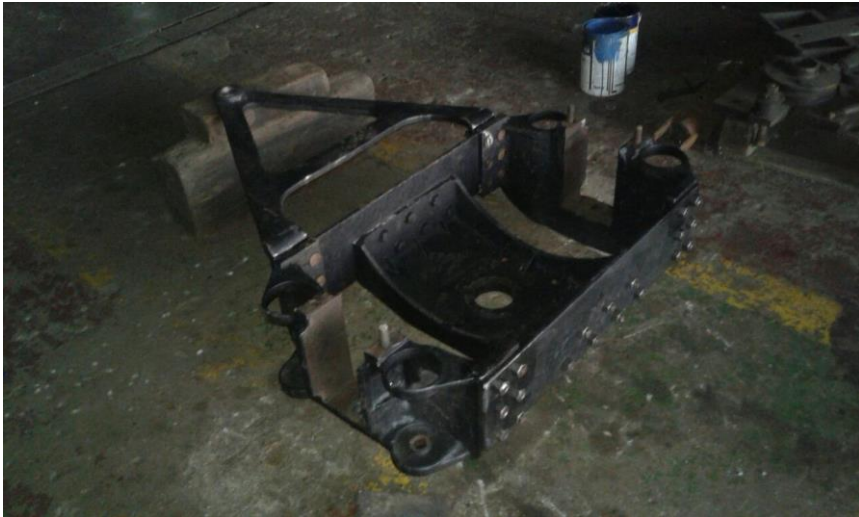
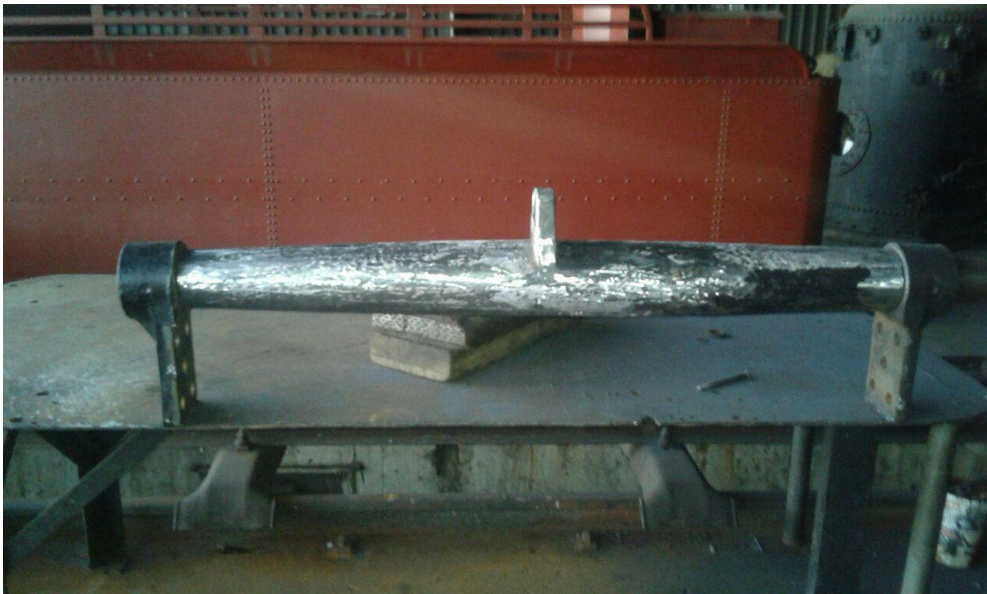
The bissel components have been returned from machining and the bissel reassembled. Work now continues on the frames and other components. As we have mentioned before this is probably the most difficult restoration done by Sandstone and so our updates tend to be about seemingly small items but which are key to the locomotive' reconstruction, and yes in reality, given the deterioration of the NG10, the restoration probably will be classified as a reconstruction.

Our pictures show the bissel components and the bissel completed plus the brake shaft which needs further work.
