## The restoration of Class NG10 number 61, 2017 progress.

### Boiler report from Keith Stevens, 5<sup>th</sup> May

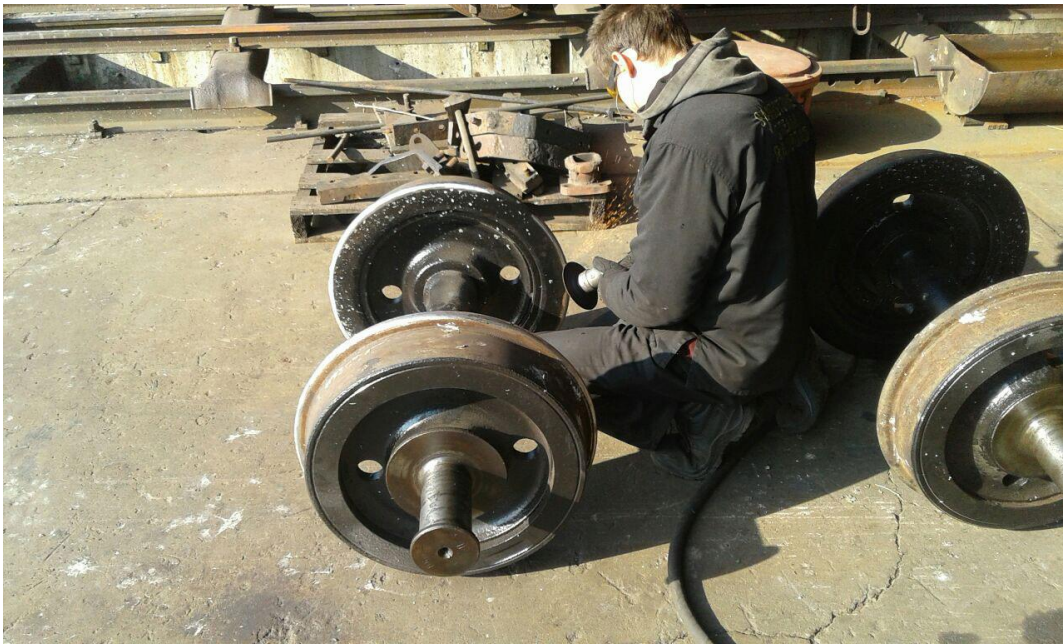
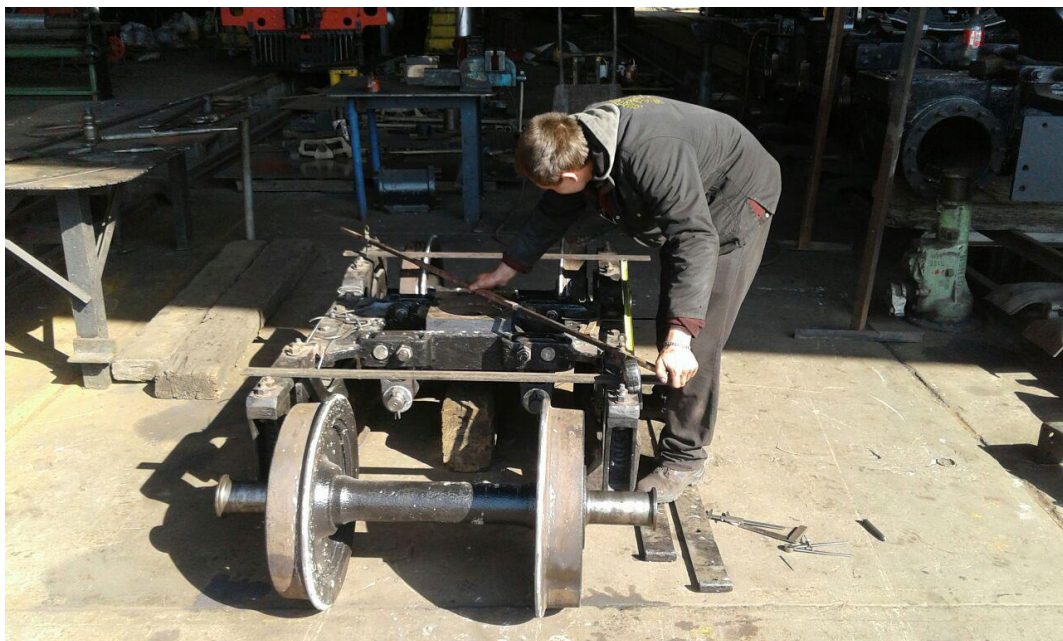
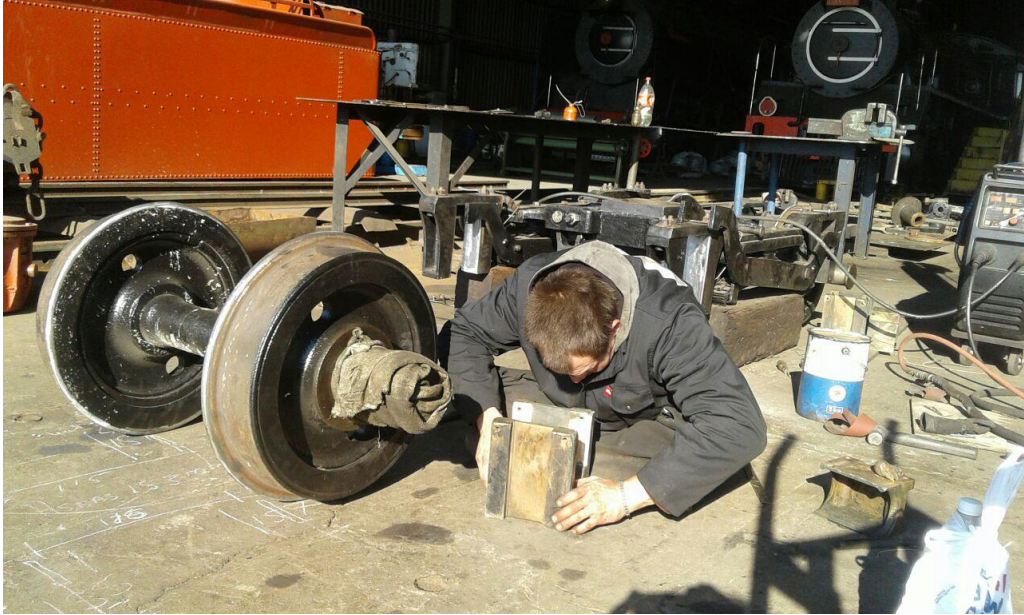
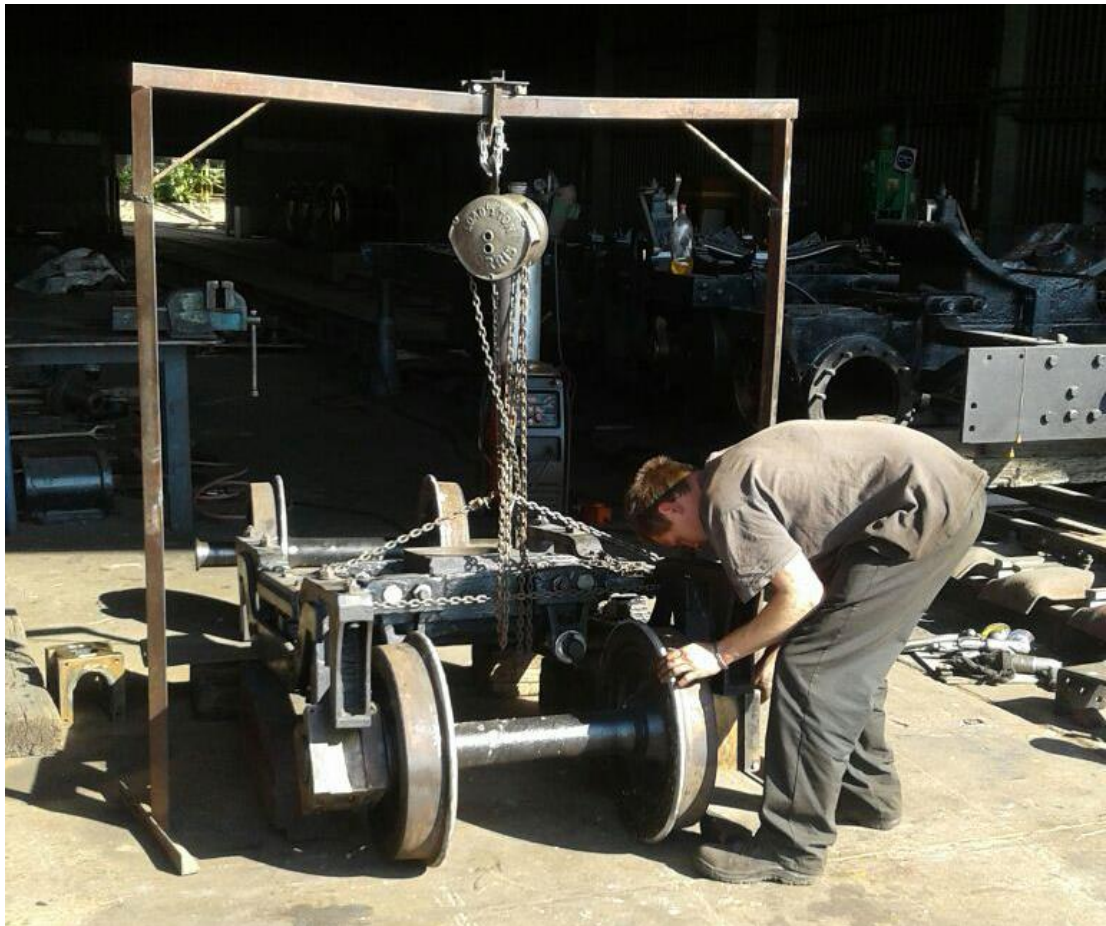
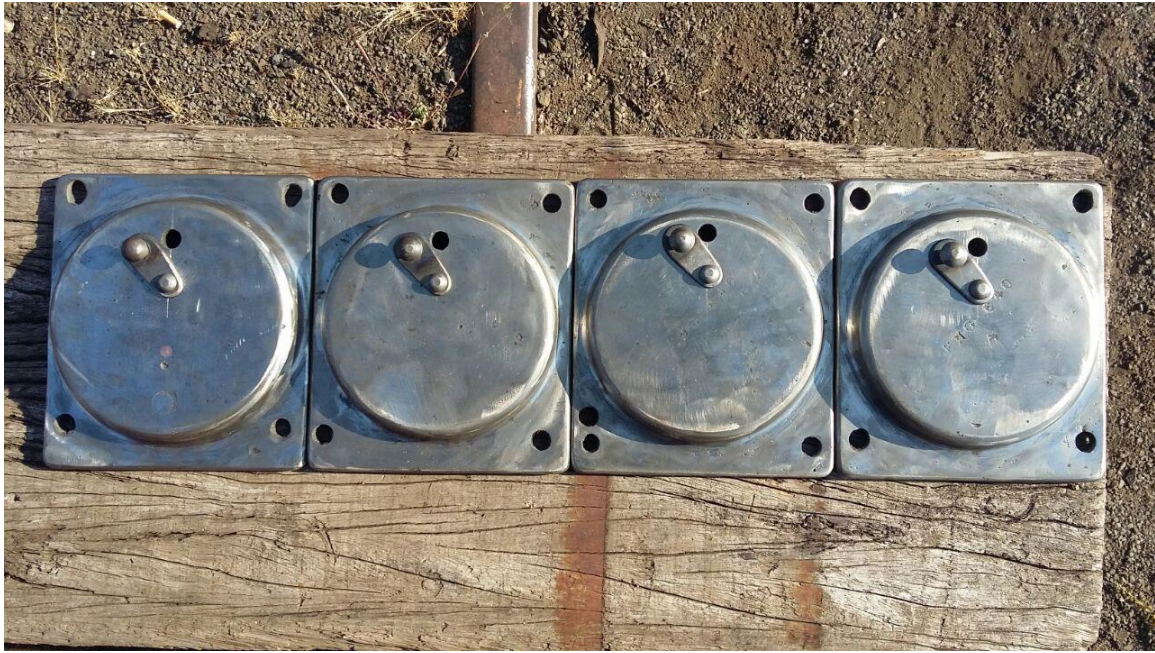
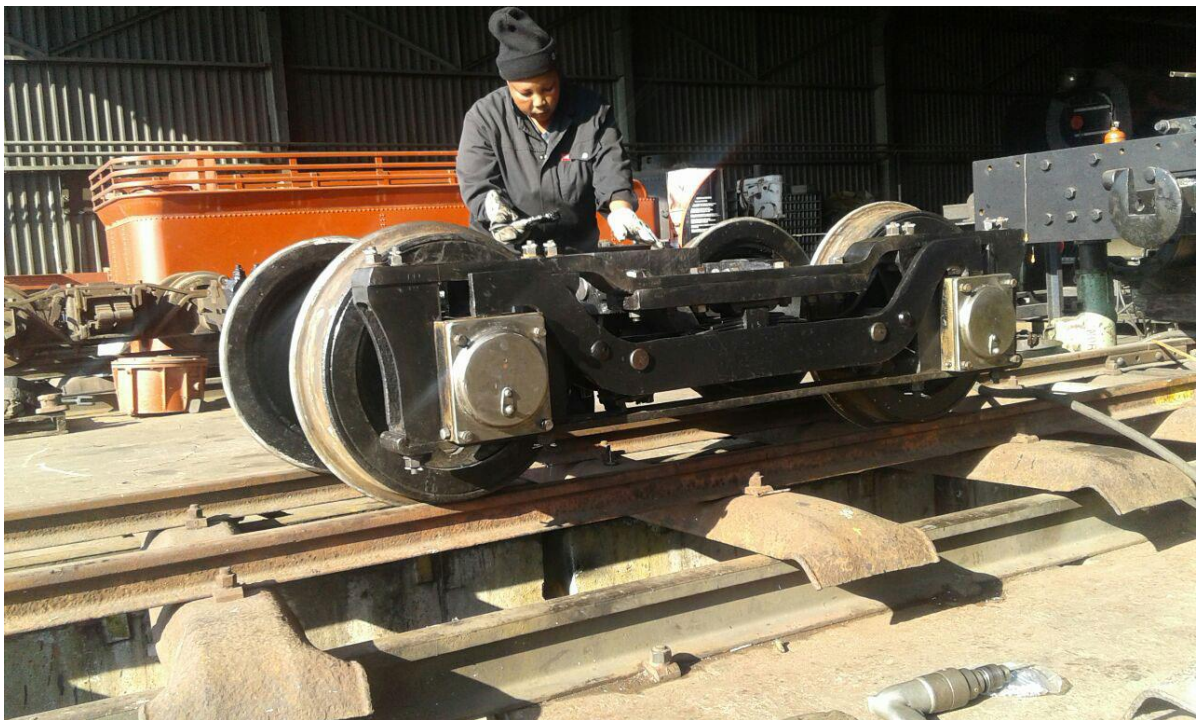
While spares are awaited to finish the bissel truck attention has shifted to the front bogie of the NG10 in Bloemfontein. Our picture gallery shows Isak vd Berg profiling the wheel flanges which were then mounted in the bogie and trembled to settle them. As they were misaligned and the axleboxes did not have the desired play to correct this, liners were welded to the bogie frame and then machined to the correct size. Remetalled axle boxes were fitted to the wheel journals and the bogie reassembled. As Sandstone has a complete set of original drawings for the NG10 new axle box covers were fabricated and the bogie is now complete and on rail.

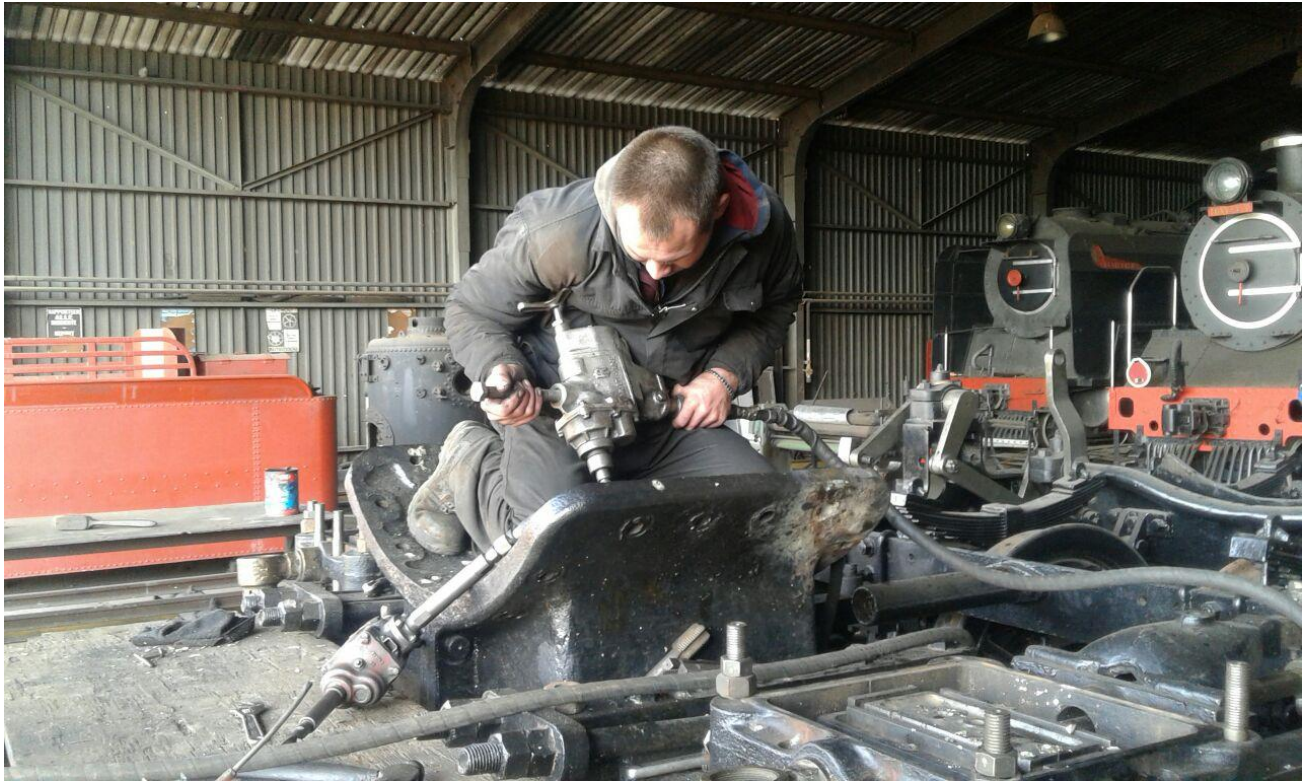
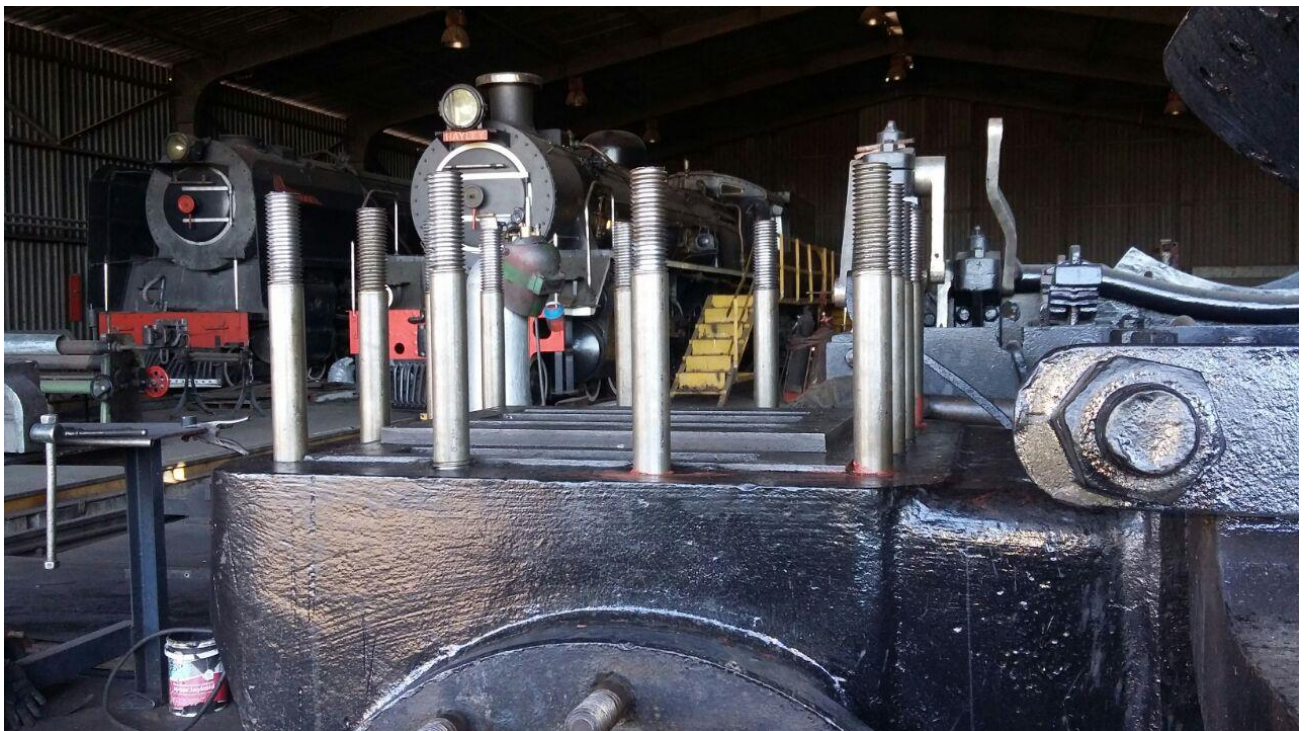
Attention has now been given to the cylinder and valve covers as all the studs were rusted solid and could not be unscrewed. They have now been drilled out, retapped and replaced with new studs as our pictures show.

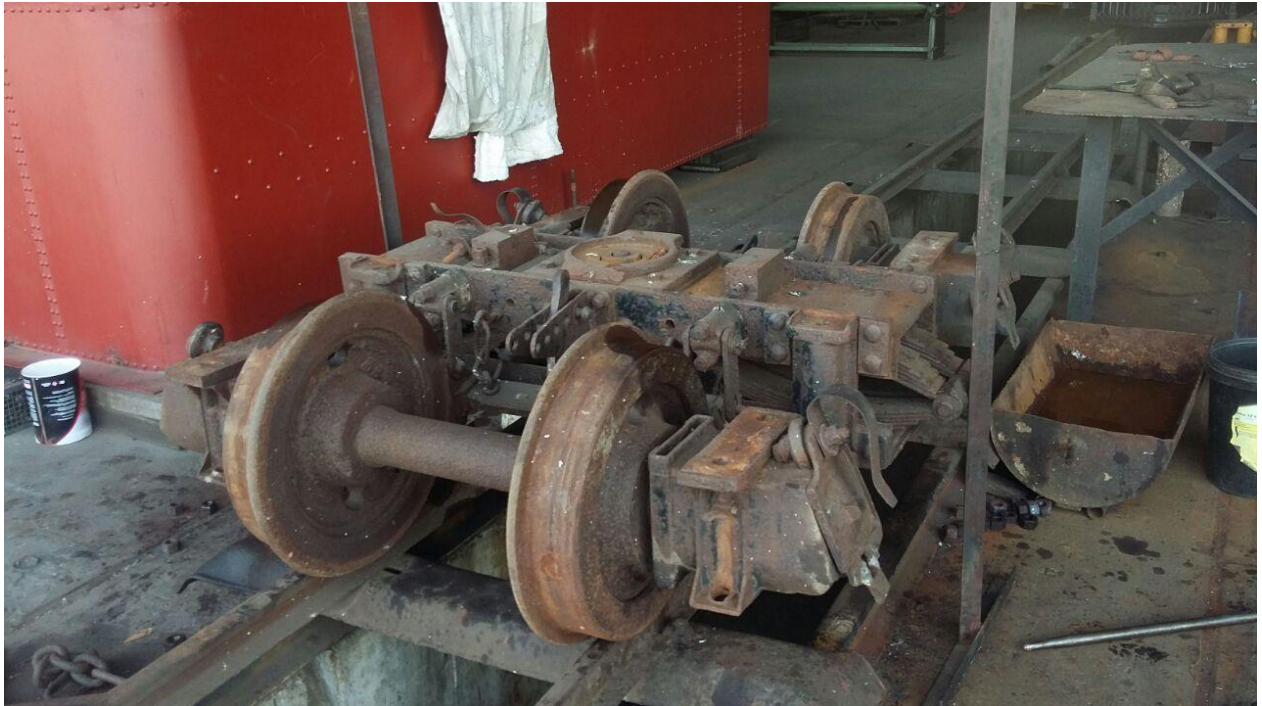
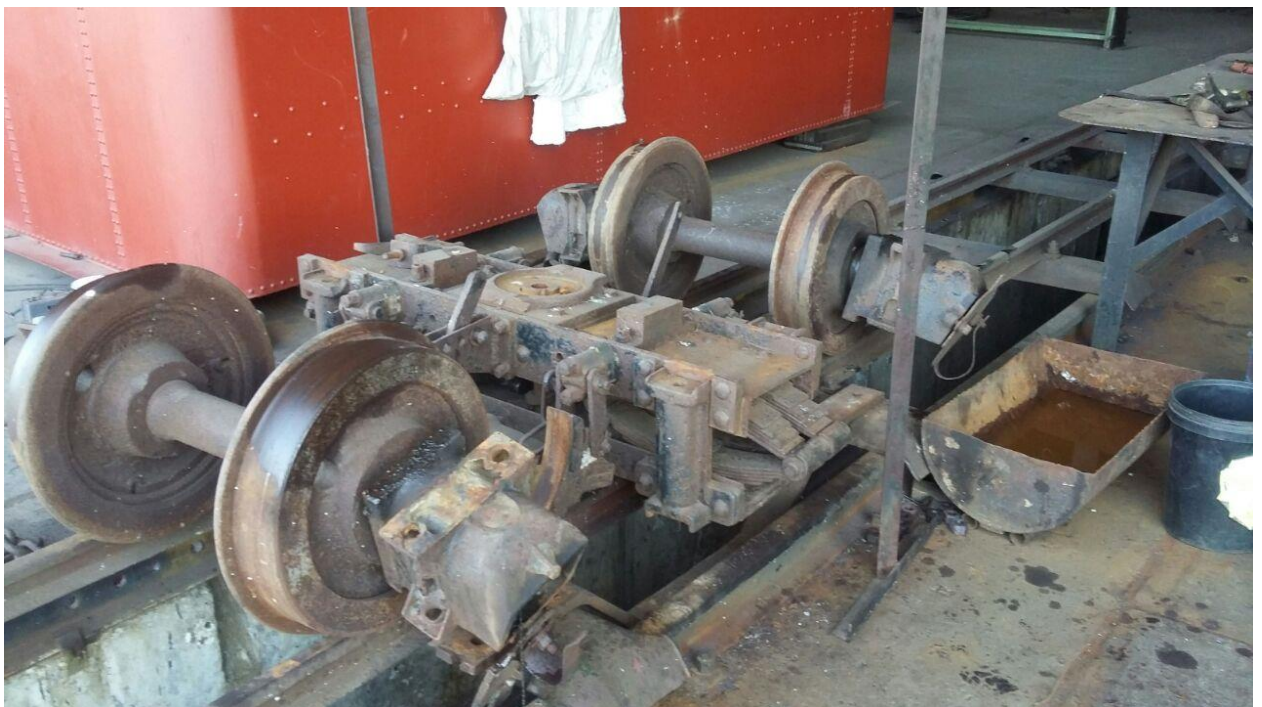
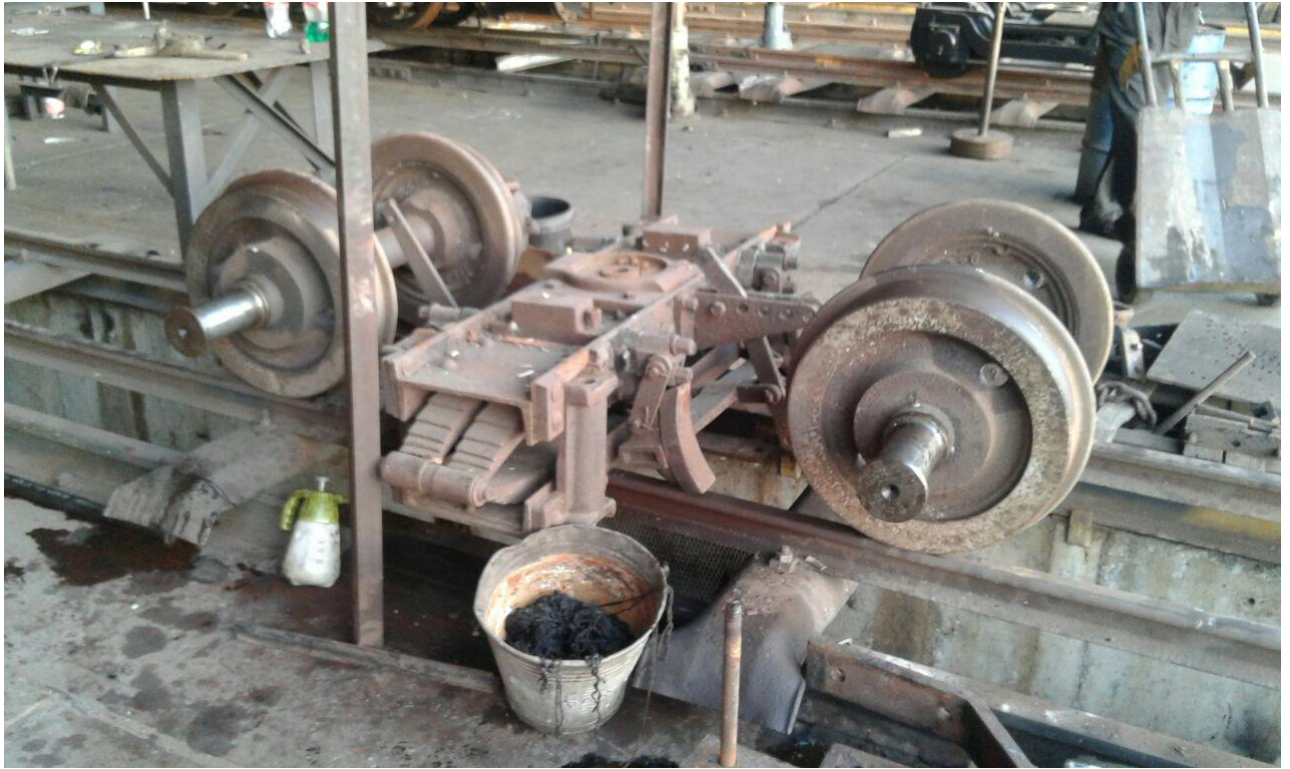
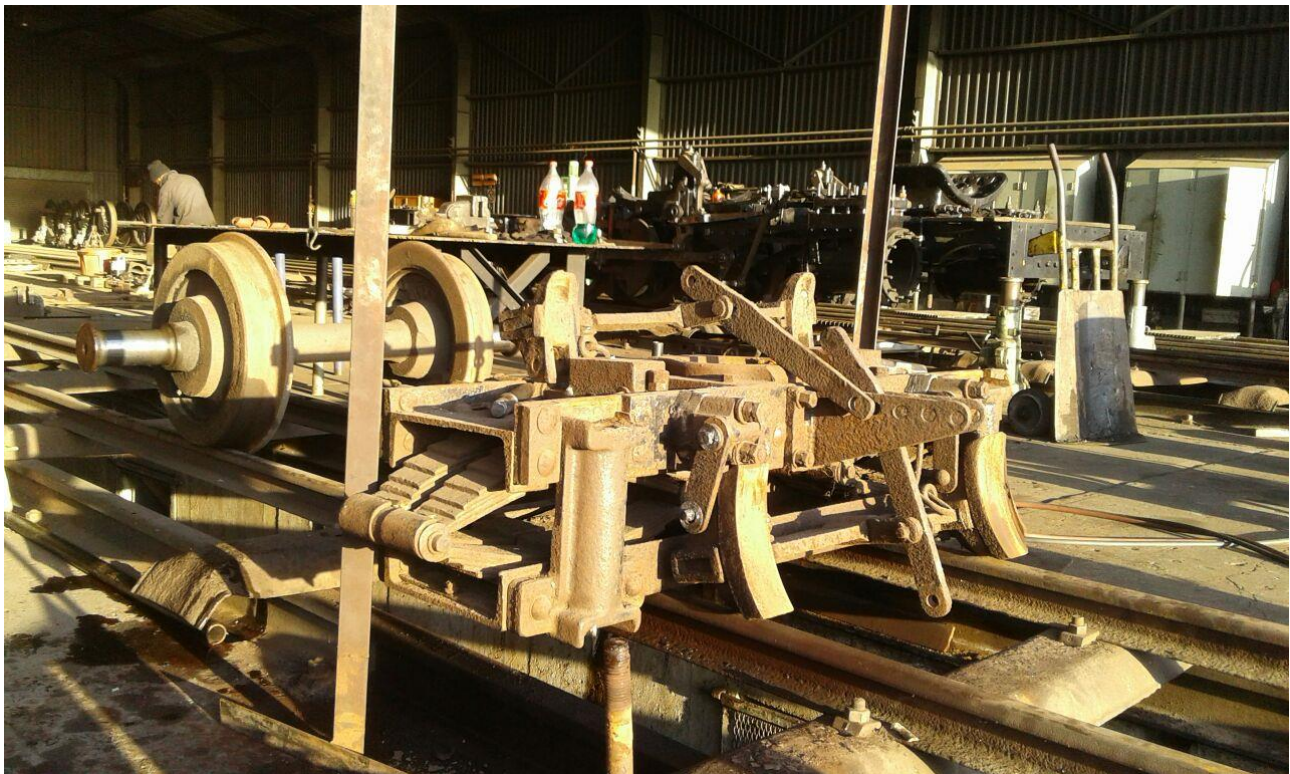
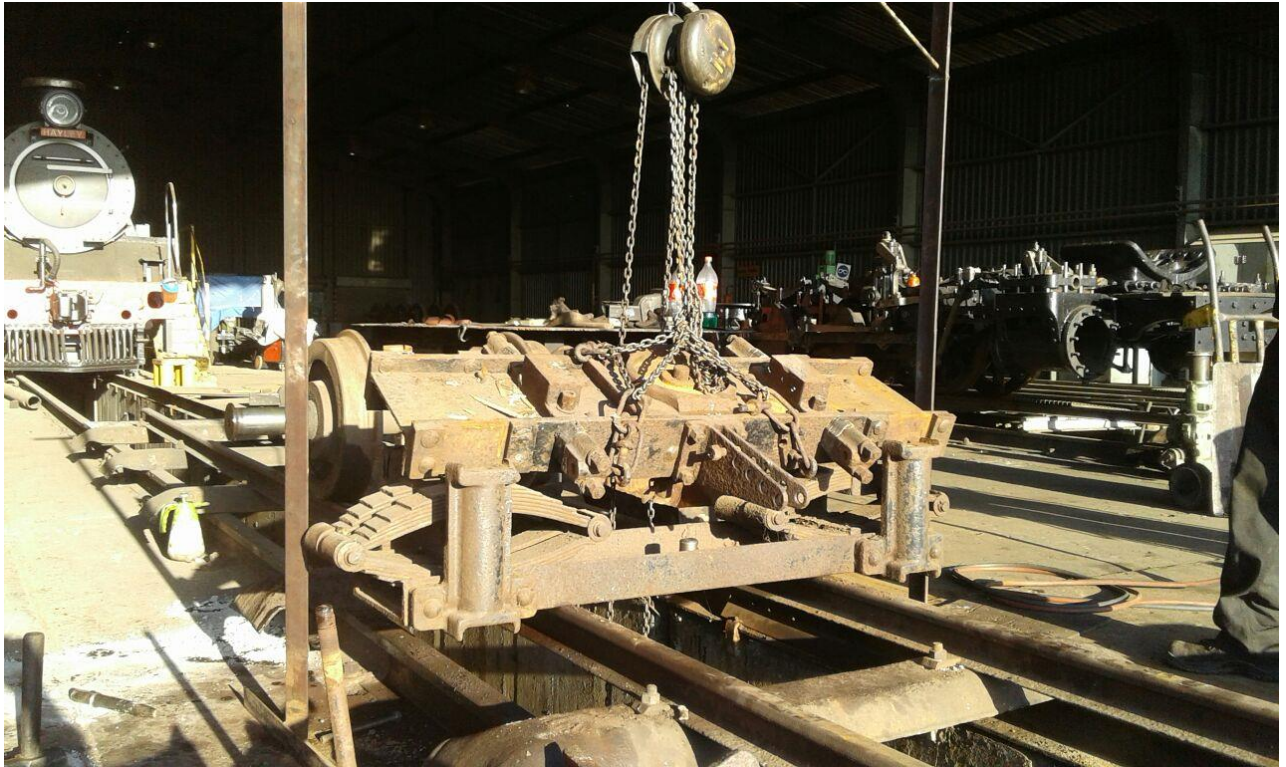
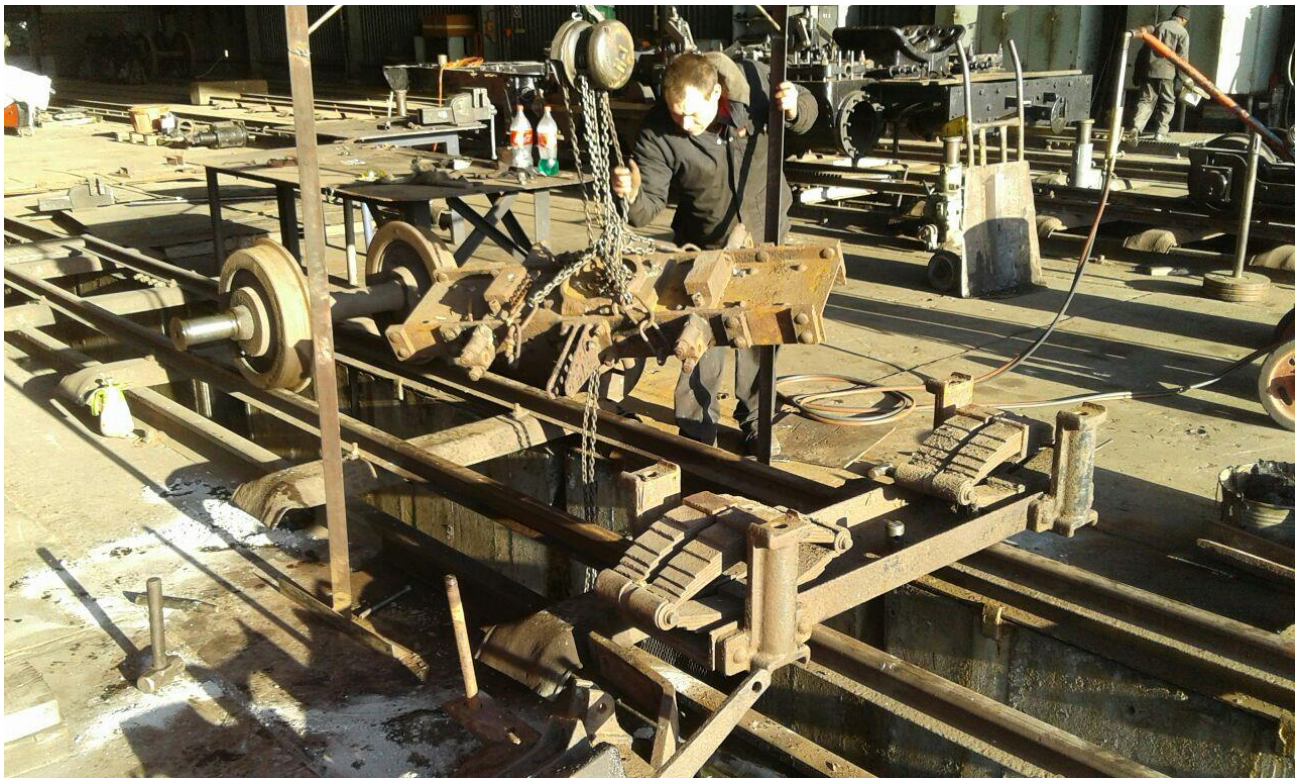
Following on from our last update, the Bloemfontein team are waiting for some parts for the motion and in the meantime have begun to strip the number two tender bogie for assessment and repairs. A complete overhaul is required as expected as many parts are damaged and all are very badly rusted.

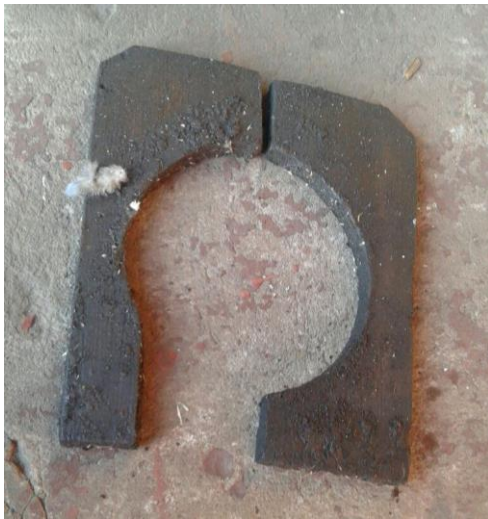
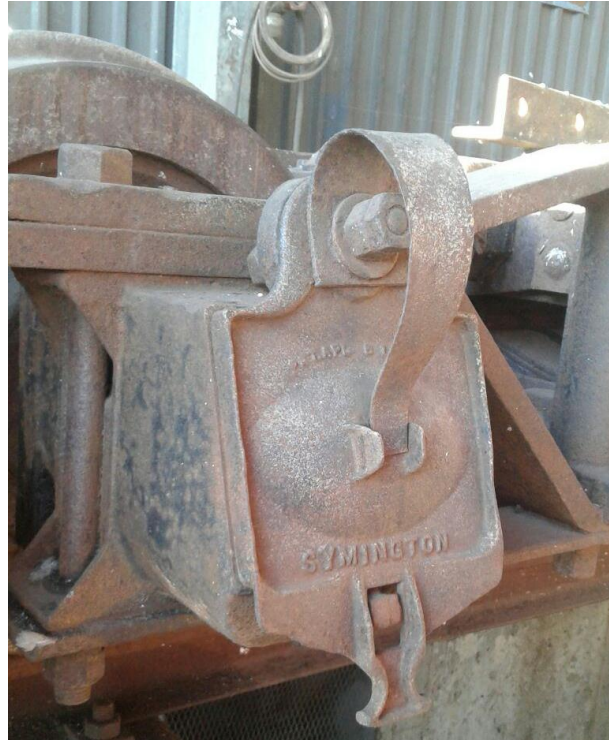
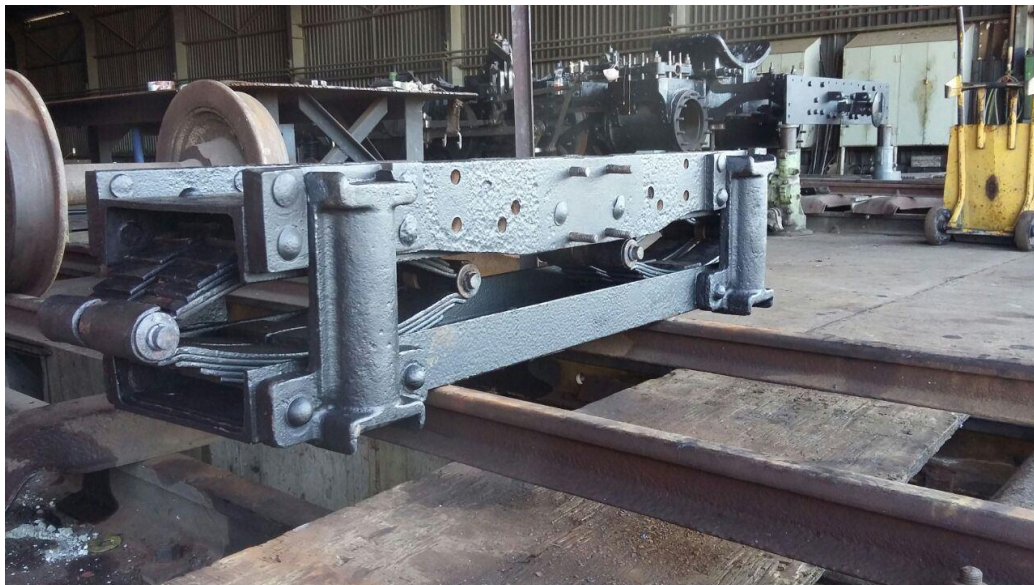
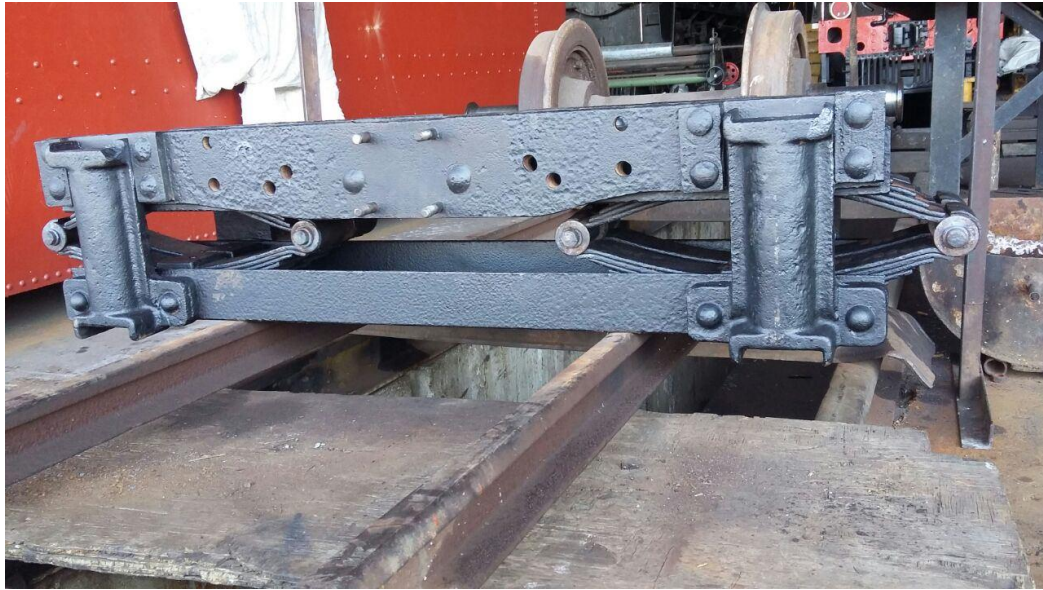
Attention has shifted to the tender bogie where some problems have been experienced. Many parts are not original with some items such as the axle box dust shields shown in the photo actually fabricated from wood. This is believed to have happened when the loco was

originally set aside for preservation. Lukas Nel and his team are looking for parts with the original look or will fabricate new ones from the NG10 drawings we have. The springs on the bogie have been pressure tested and the centre part of the bogie is being assembled. All this work is time consuming but necessary to complete the standard of restoration required.

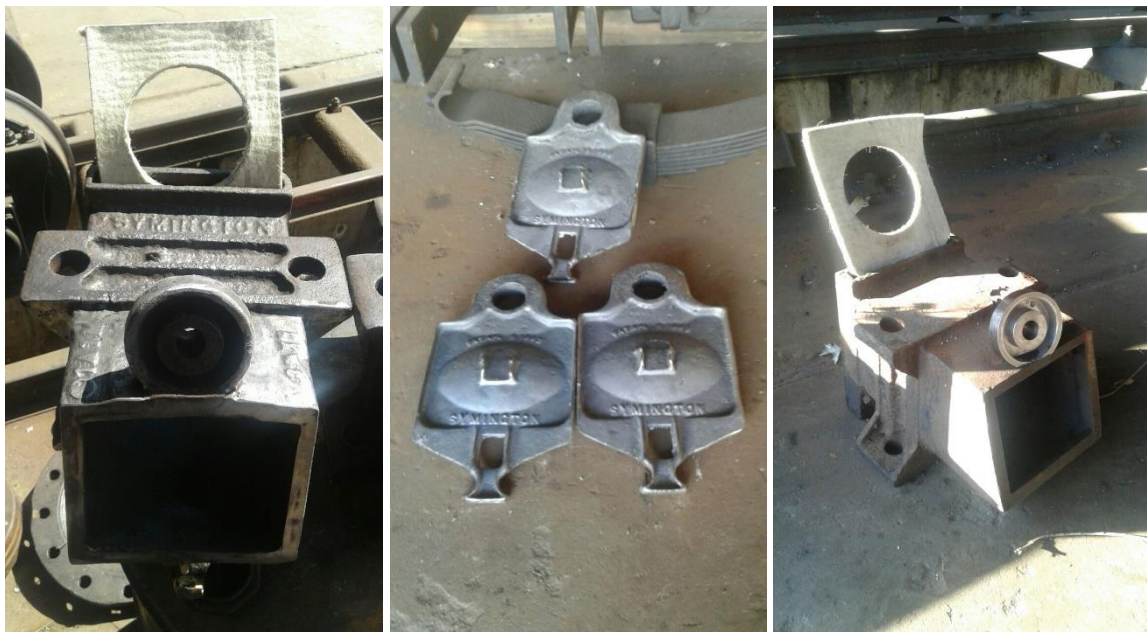
The Bloemfontein team have received some spares from the machine shop but exciting news is the acquisition of some axle boxes that may be modified so that the rebuilt tender will now have eight boxes of the same type

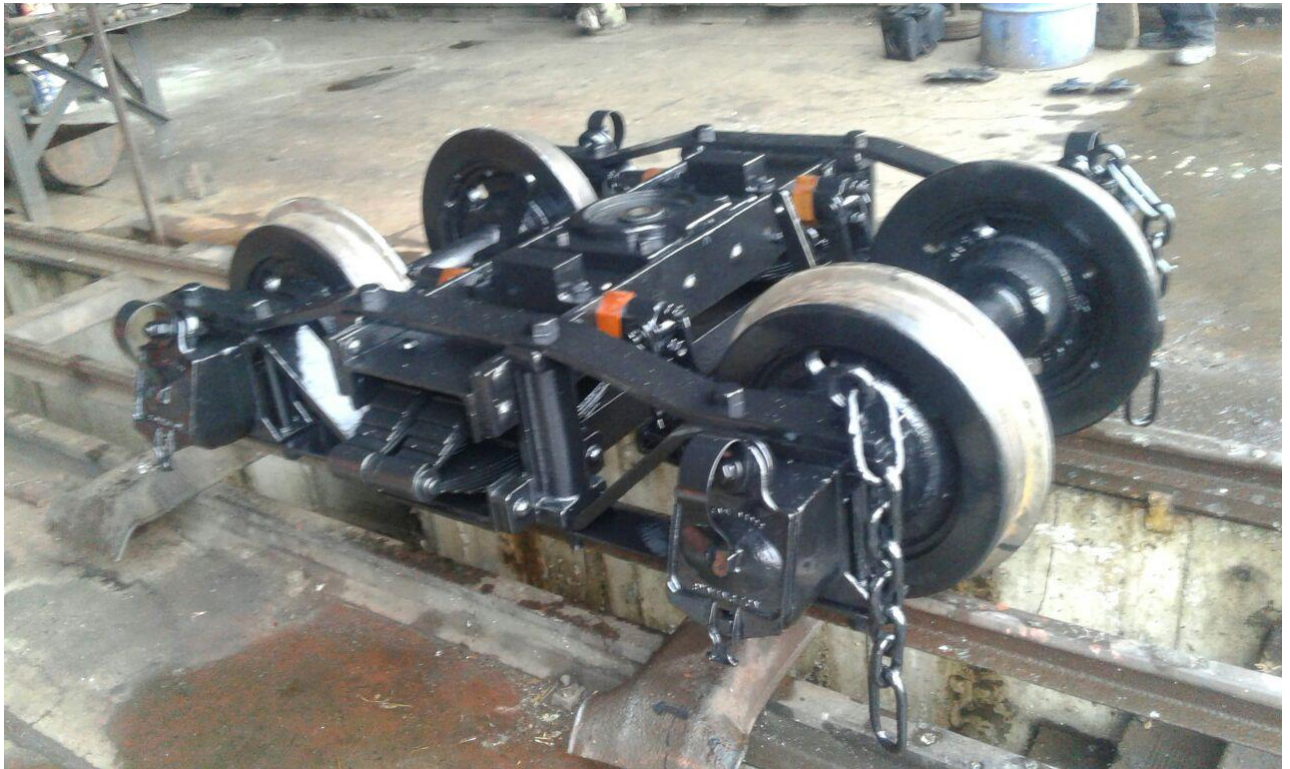
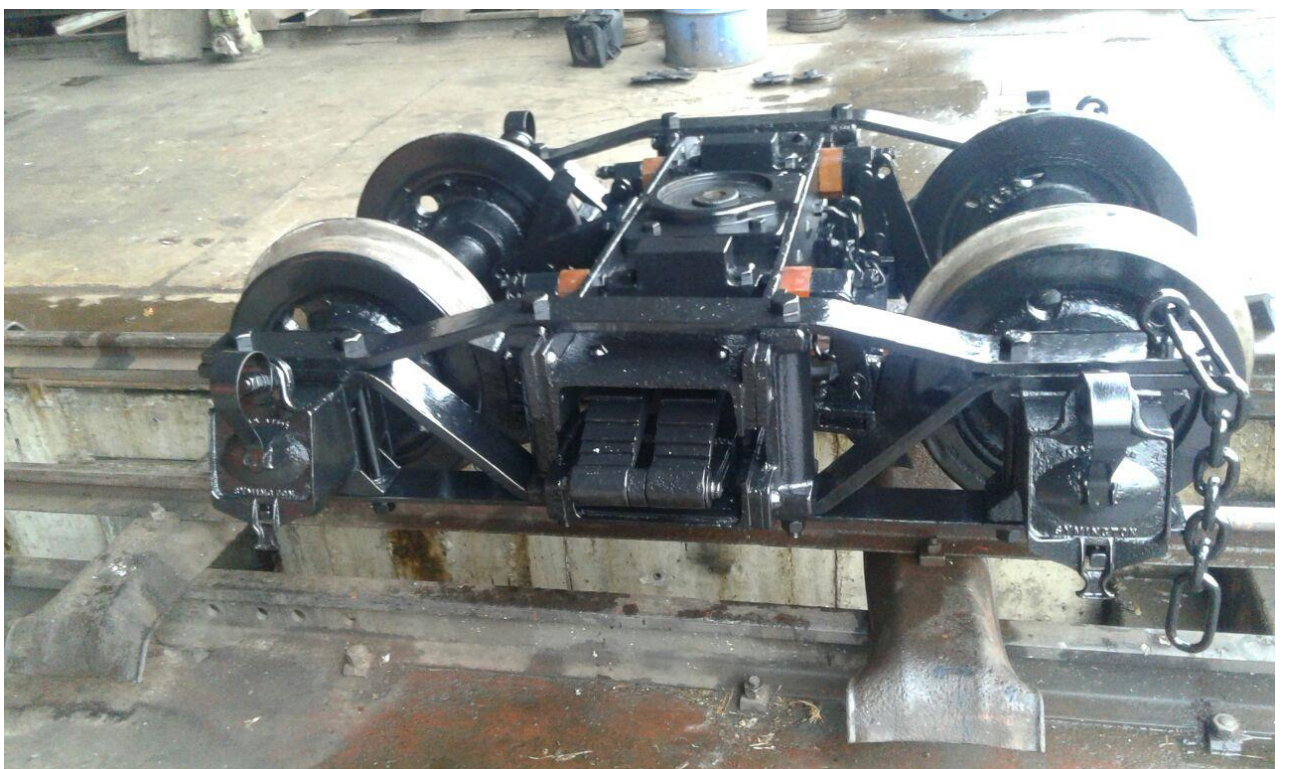
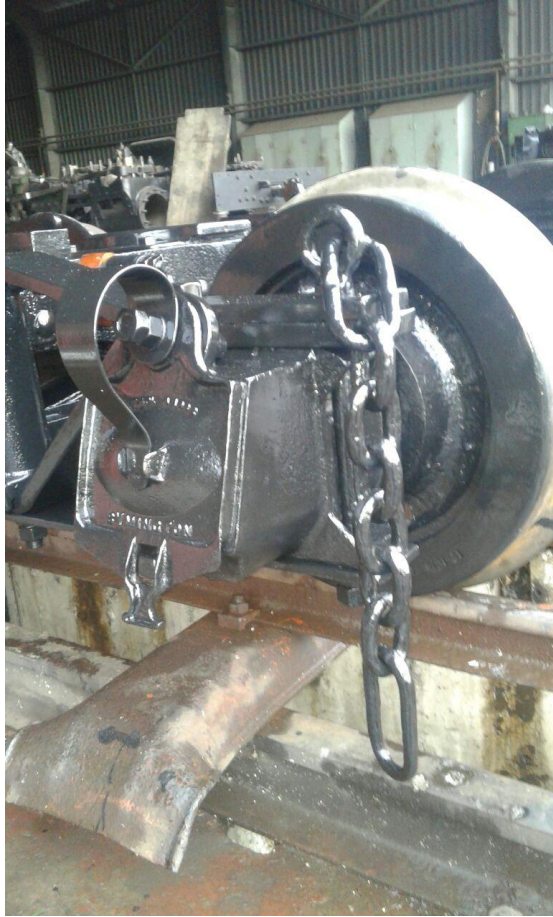
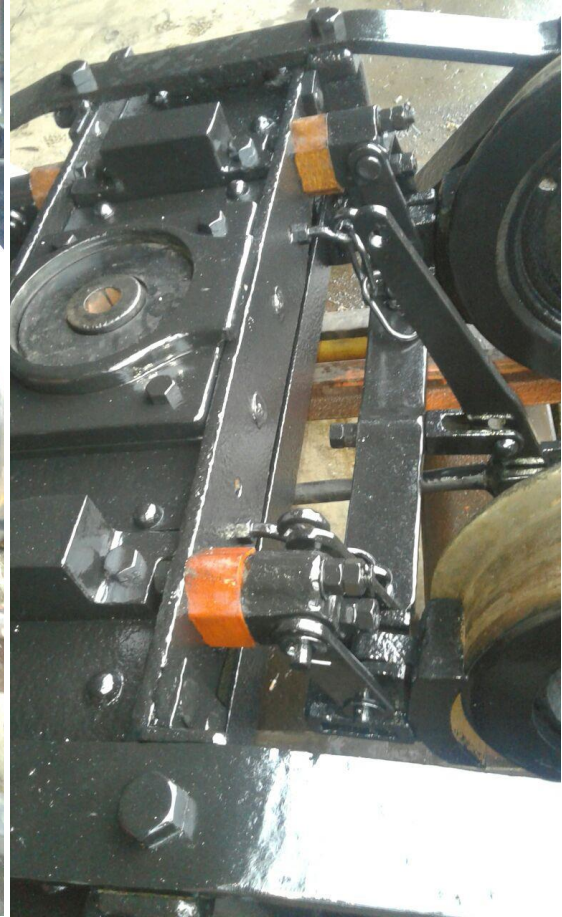
The hard work put in by Lukas Nel and his team over the last few months is now coming to fruition with the completion of the first of the two tender bogies for NG10 number 61. Our pictures of the first completed bogey show how the team almost travelled back in time to

produce the units as they were in 1915 when the locomotive rolled out of the Baldwin workshops in the USA.
